GS7000, GainMaker, and 694X Node Transmitter RF Shutdown Technical Bulletin

The optical transmitters of the GS7000, GainMaker, and 694X Nodes with specific date codes may have a defective capacitor which results in RF shutdown.

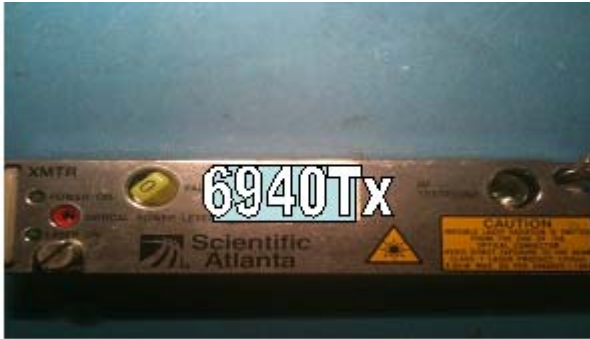
Illustration #6-6940 Tx

The following illustration shows a 6940 transmitter. The capacitor can be inspected via the RF test point opening using an ostoscope at an angle.

Note: If you are unable to determine the date code, return the module for service. Refer to *Support Telephone Numbers* (on page 10).
