Model GS7000 GainMaker Node RF Cable Technical Bulletin

A small percentage of Model GS7000 GainMaker® Nodes that were manufactured and shipped prior to May 2008 may exhibit an intermittent "no RF" or "low RF" condition in the forward or reverse path. This condition can be caused by forward or reverse RF cables that have intermittent continuity.

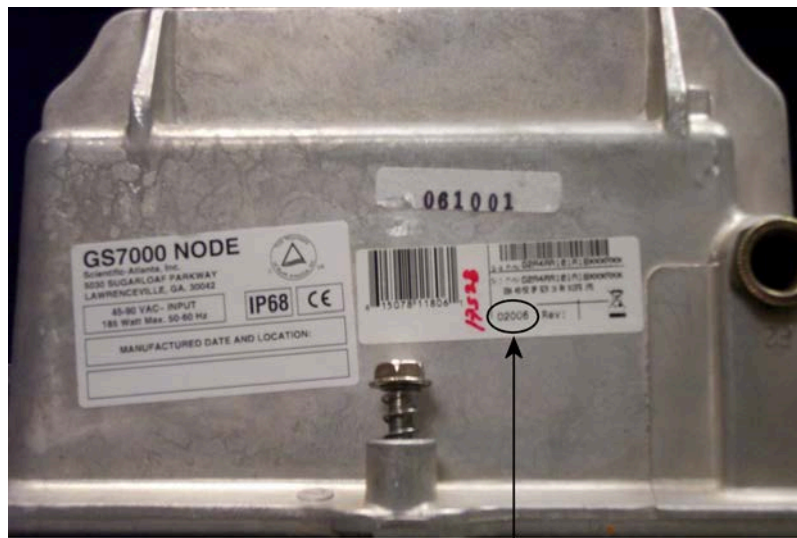
Manufactured Date Code

Model GS7000 Nodes with manufactured date codes before May 2008 (E2008) could be affected by this issue.

The manufactured date code appears on one of the product labels affixed to the side of the node housing. The following illustration shows the location of the date code. The date code in this example is D2006.

Note: The letter in the date code indicates the month of manufacture, e.g., A = January, B = February, C = March, D = April, E = May.

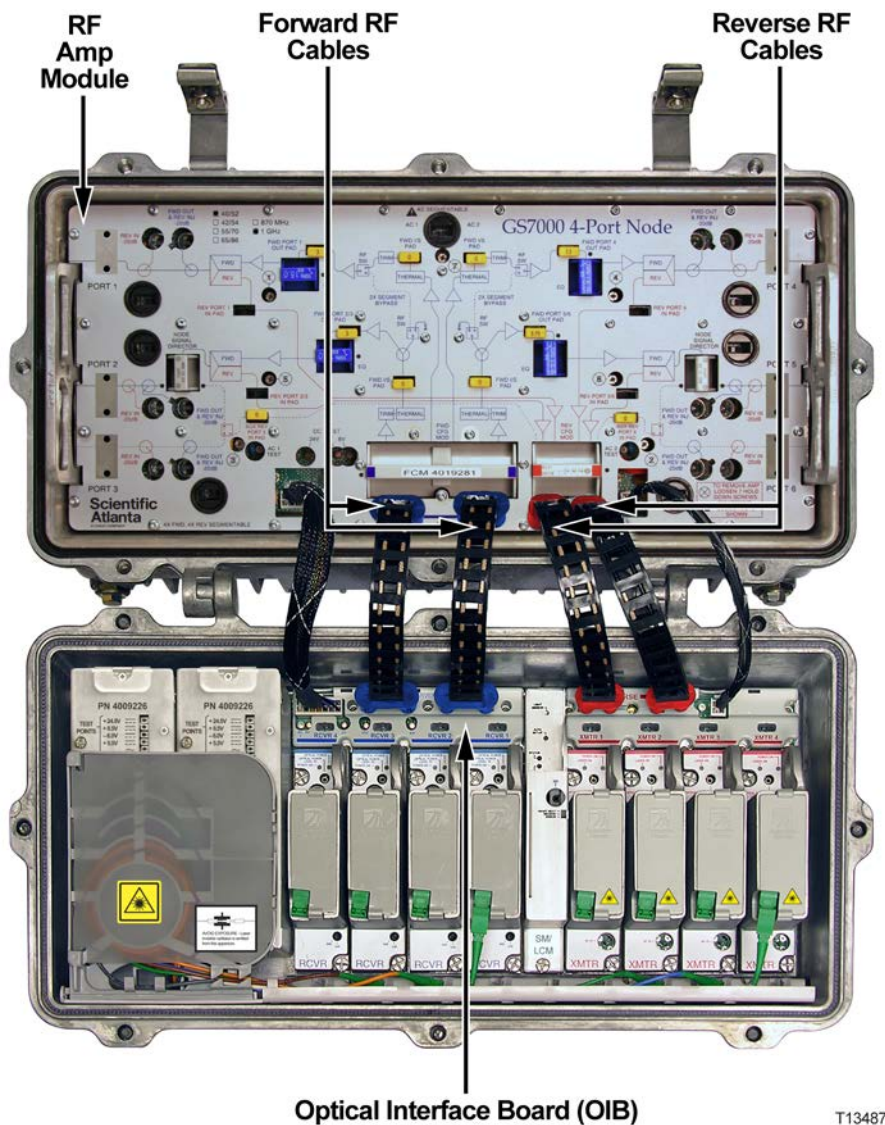
RF Cable Locations

The plug-in RF cables are located between the RF Amplifier Module and the Optical Interface Board (OIB). The RF cable connectors have color-coded plastic molded ends. The forward RF cable connectors are **Blue** and the reverse RF cable connectors are **Red**.

The following illustration shows the location of the cables in an analog reverse node.

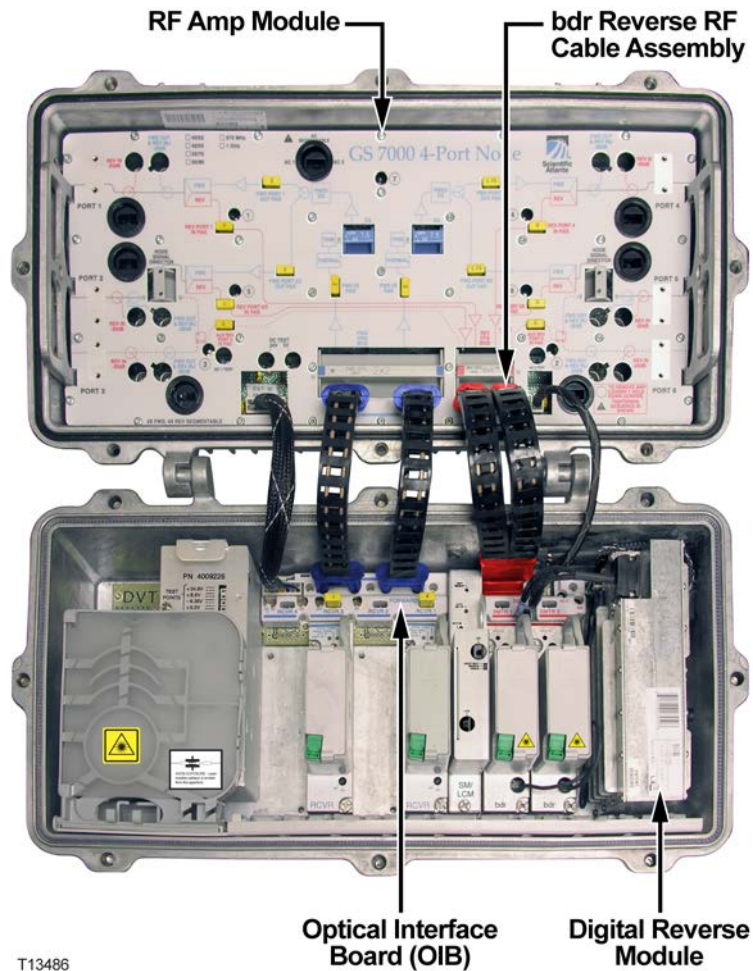
T13486

The bdr™ reverse RF cable connectors are also **Red**. The following illustration shows the location of the cables in a bdr digital reverse node.

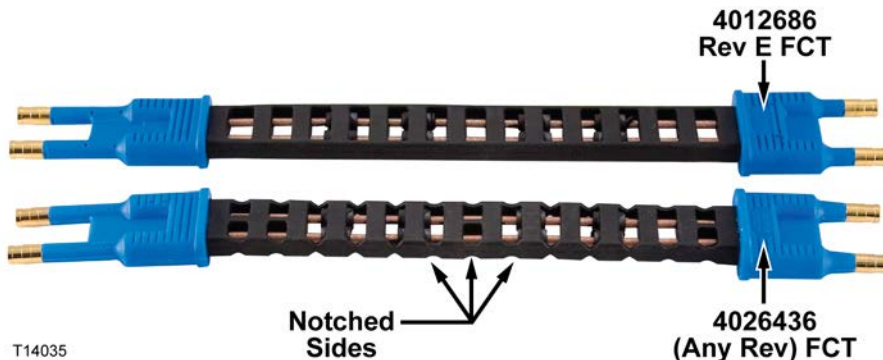
Forward RF Cables

The following illustration shows the forward RF cables and their part numbers/revision levels. Their plastic molded connector ends are **Blue**.

Note: Either cable can be used. Both the part number 4012686 Rev E cable or any revision of the part number 4026436 cable correct the intermittent continuity issue described in this technical bulletin.

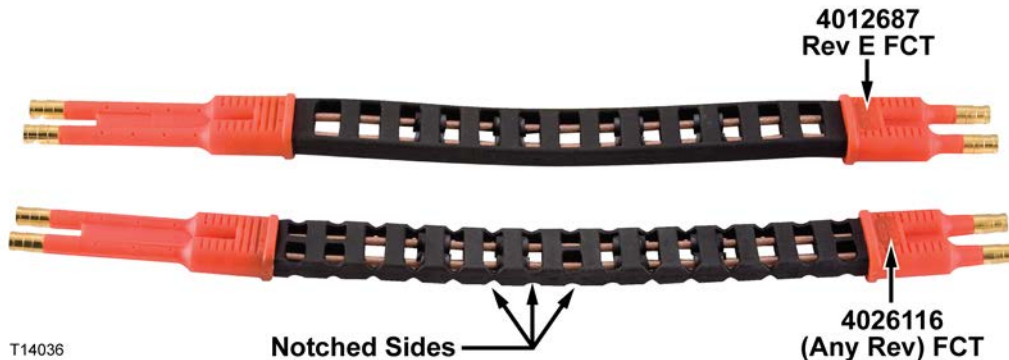
Reverse RF Cables

The following illustration shows the reverse RF cables and their part numbers/revision levels. Their plastic molded connector ends are **Red**.

Note: Either cable can be used. Both the part number 4012687 Rev E cable or any revision of the part number 4026116 cable correct the intermittent continuity issue described in this technical bulletin.

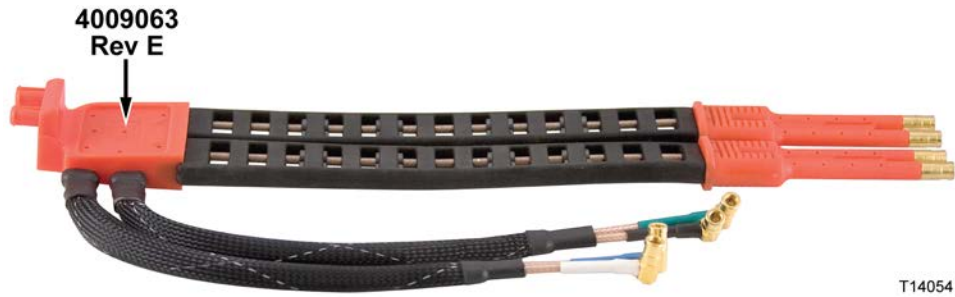
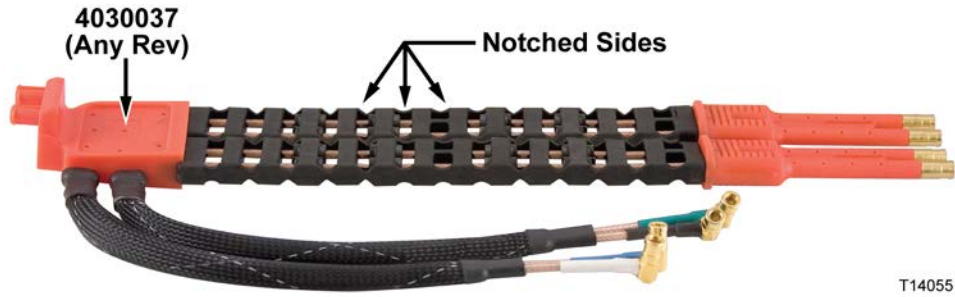
bdr Reverse RF Cables

The following illustrations show the bdr reverse RF cables and their part numbers/revision levels. Their plastic molded connector ends are also **Red**.

Note: Either cable can be used. Both the part number 4009063 Rev E cable or any revision of the part number 4030037 cable correct the intermittent continuity issue described in this technical bulletin.
