# Prisma II 1310 nm AGC Transmitters Display White Lines Technical Bulletin

This technical bulletin applies to all cable system operators and technicians who use Prisma II™ 1310 nm Transmitters with manufacturing date codes between February 2003 (B03) and September 2003 (J03).

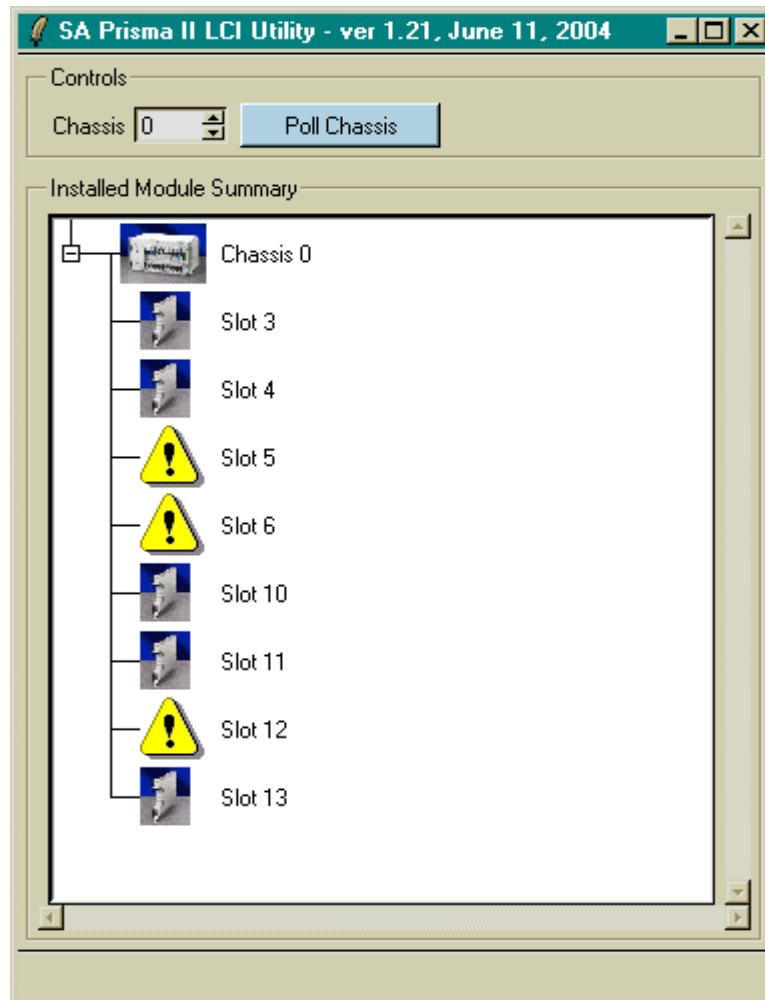
**Result:** If connected and the Chassis ID is set correctly, an Installed Module Summary displays similar to the following:

In the example above, slots 5, 6, and 12 contain transmitters that require an update. Slots 4, 10, 11, and 13 contain units that do not need an update.

**Note:** Slot 3 is the fan tray of the chassis, not a transmitter.

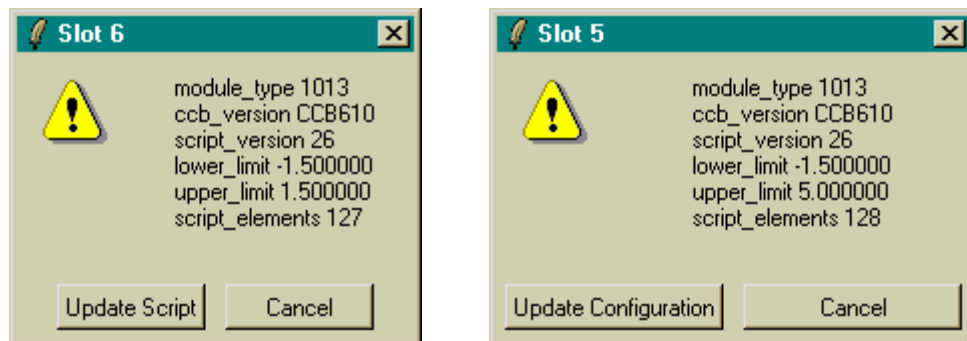
**Result:** A message similar to one of the following displays.

**Note:** The specific message you receive indicates whether the transmitter in that slot needs a “configuration” update or a “full script” update.

10. Click the **Update Script** button or the **Update Configuration** button to start the update.

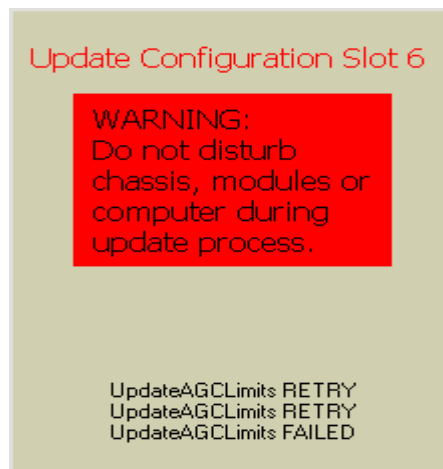
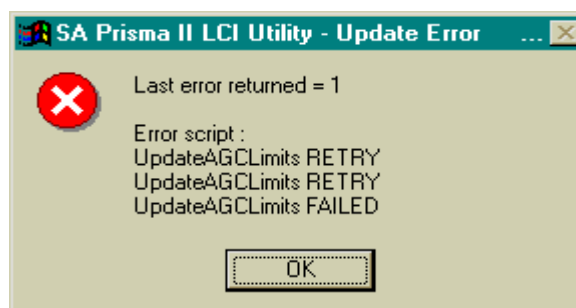
11. If you try to start the update and there is a communications failure, a message similar to the following displays.

If you receive a similar message, check the following:

- Is the transmitter you are trying to update still secure in the chassis?
- Is the RS-232 serial cable still connected properly?

After checking these items, click **OK** in the update error message box and then retry the update starting at step 9.

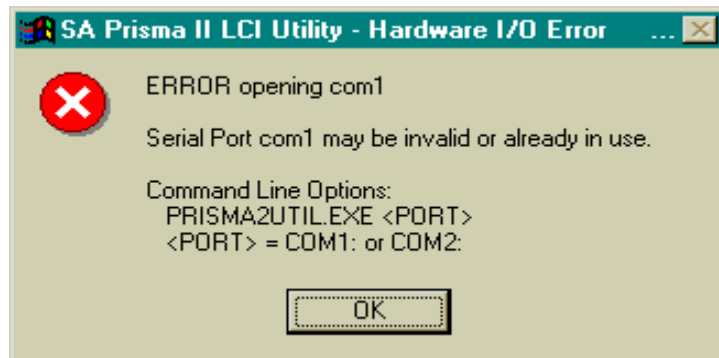
If you receive an error message similar to the following when starting the utility, you probably have a conflict with the selected COM port.

First make sure that you have connected the RS-232 serial cable to the correct COM port on your computer, and make sure all other programs that may be using that COM port are shut down. Then click the OK button and try to start the update utility again.

The update utility defaults to using COM1. If you need to change to a different COM port follow these steps.
