# Prisma II 1310 nm Reverse Transmitter Low RF Reading with RF Tap Terminated Technical Bulletin

## Situation and Conclusion

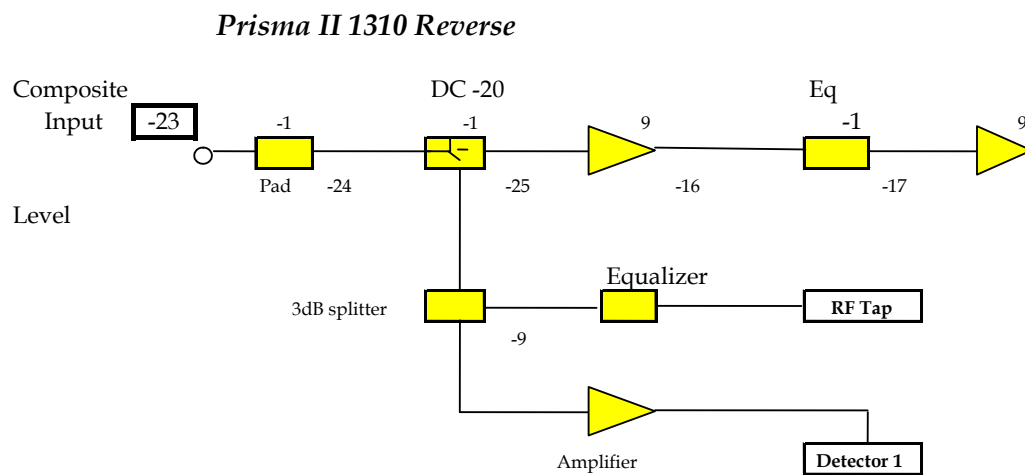
The following block diagram serves to illustrate the reason for this occurrence.

Per the design of the Prisma II 1310 nm Reverse Transmitters circuitry, the RF Tap and Video Detector circuit share a common output point at the 3 dB splitter. Under normal operating conditions, (i.e., RF tap is open-circuited) the RF tap leg of the 3 dB splitter will present a higher impedance path than when the tap is terminated with 75 ohms. This in turn has the effect of transferring more RF power to the detector leg of the splitter.

Tests were conducted and these tests showed that when the RF tap is not terminated, the voltage at the splitter node is higher by 52 mV than when terminated. This voltage translates into a -1.17 dB difference reported to the ICIM, LCI, TNCS and ROSA software. An impedance different from 75 ohms, for example, poor return loss of instrument, will give another tolerance. It has been confirmed by Cisco that this only has an impact on the ICIM, LCI, and TNCS and ROSA software reading, and has no affect upon the RF power used to modulate the laser. This has been verified by confirming the RX output power does not vary, when the RF tap on the reverse TX is terminated.

The RF power reported by ICIM, LCI, TNCS, or ROSA software will be approximately 1.0 dB to 1.5 dB lower than actual performance when a load is present at the RF test point on the module front panel. This condition is caused by a variance in the test point load presented by the operator and will not effect the performance of the actual RF power. When the RF power is being monitored by ICIM, LCI, TNCS, or ROSA software, take care to ensure the RF test point on the front panel is not loaded.
