Prisma II High Density Transmitter Intermittent Video Flash or Alarm Technical Bulletin

This document informs users of Prisma II 1310 nm and QAM high density transmitters of possible intermittent failures with these modules, and explains how to perform a software update that resolves this issue.

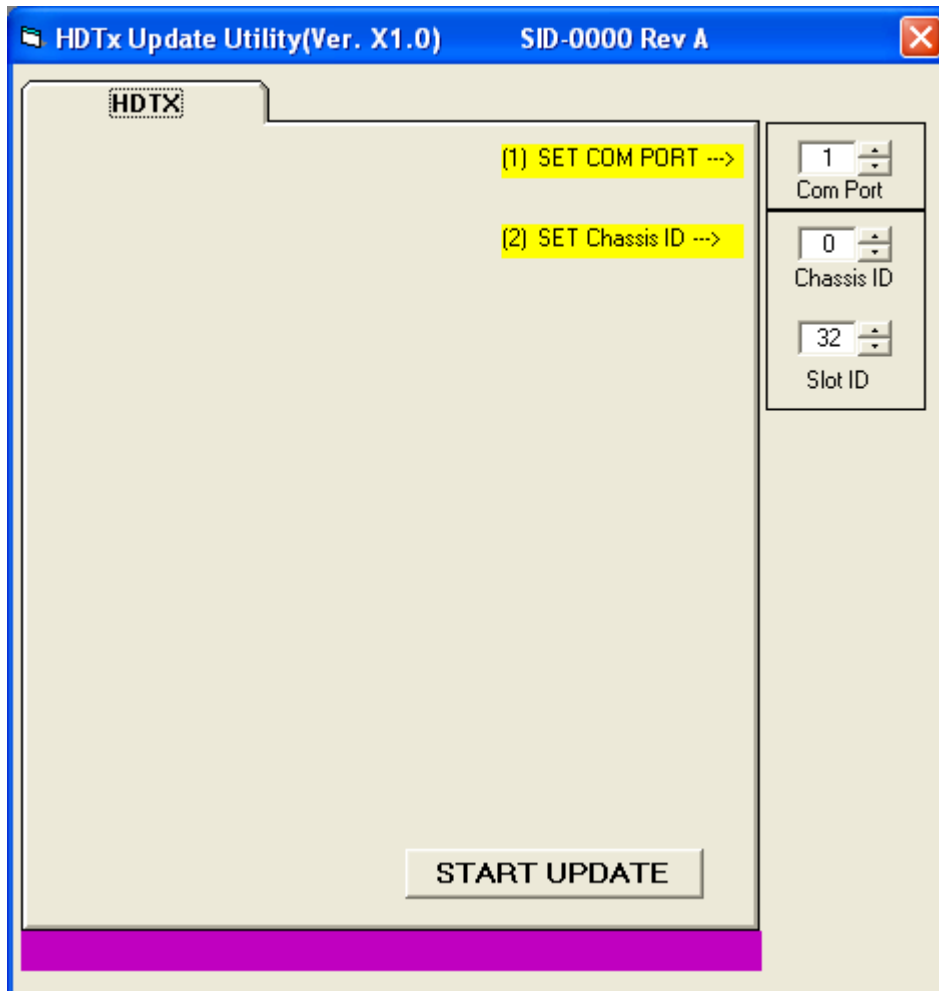
- 1 From your Windows desktop, choose **Start > All Programs > HDTx Update > HDTx Update** to launch the HDTx Update Utility. The main program window opens, as shown below.

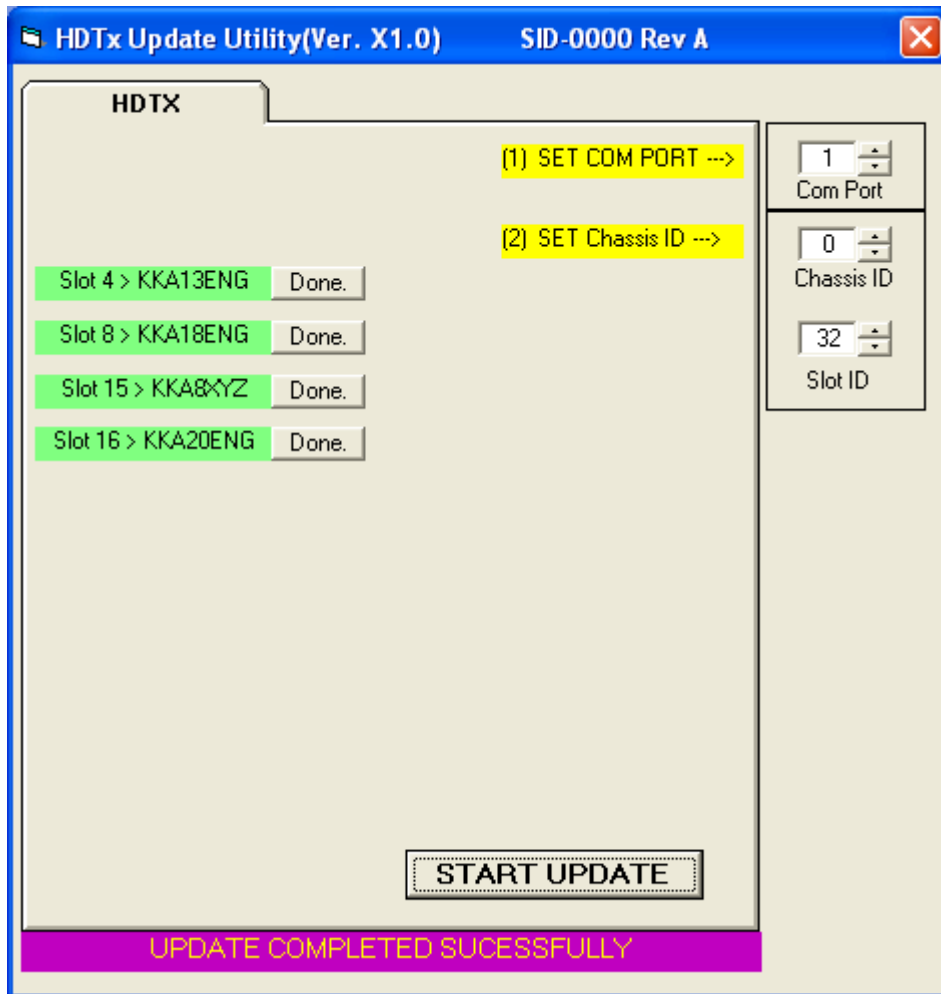
- The utility now verifies that the update was successful, and if so, displays a confirmation message in the status bar, as shown below.

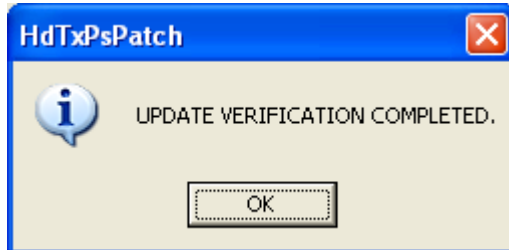
The following window pops up to indicate verification of the update:

Click **OK** in this pop-up window to complete the update.

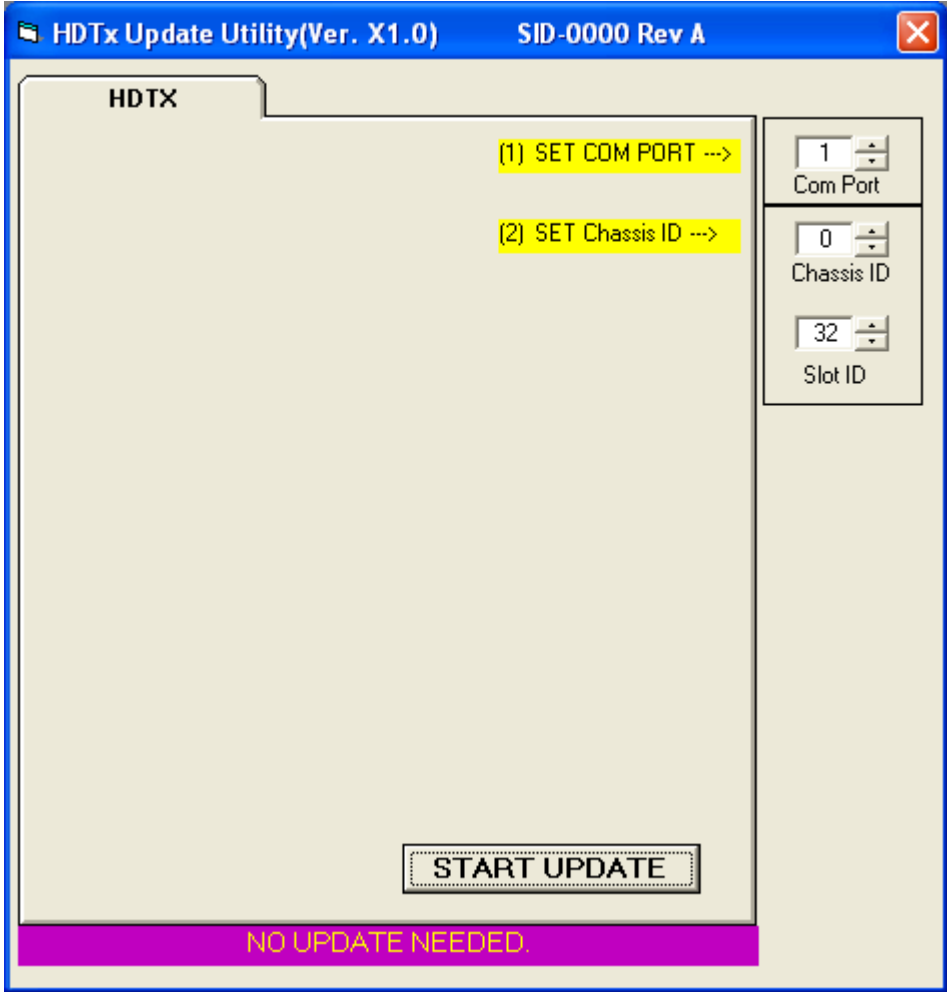
If the utility does not locate any units in the chassis that require updating, it displays the message No Update Needed, as shown below.

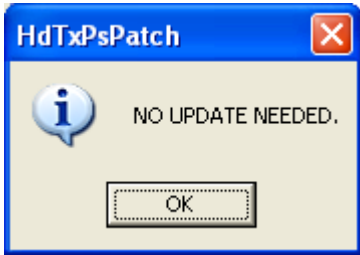
The following pop-up window also appears.

Click **OK** in this window to terminate the update utility.
