Migrate to Cisco UCS IOM 2408

Product overview

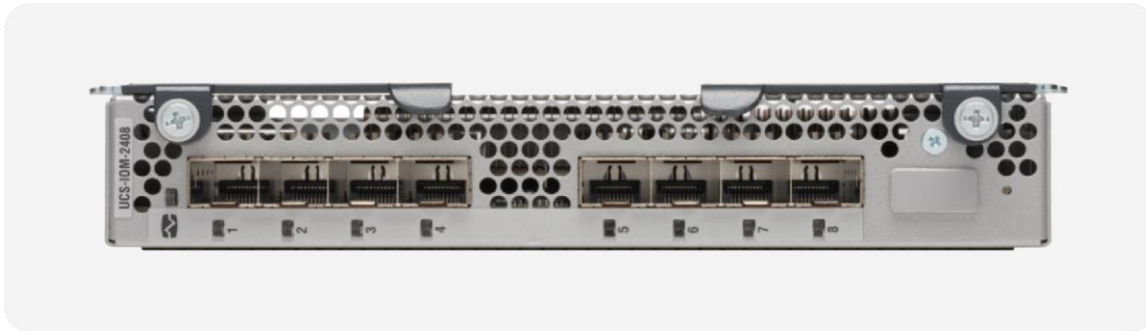
Figure 1.
Cisco UCS I/O Module 2408, front view

The fourth-generation Cisco UCS® I/O Module (IOM) 2408 provides unified fabric connectivity for the Cisco UCS 5100 Series Blade Server Chassis. IOM 2408 supports eight 25-Gigabit unified Ethernet ports to connect the Cisco UCS 5108 Blade Server Chassis with Cisco UCS Fabric Interconnect (FI) 6400 Series. Each IOM 2408 has four 10-Gigabit backplane Ethernet connectivity through the midplane to each half-width blade server in the chassis, thus giving a total of thirty-two 10G backplane Ethernet interfaces from an IOM 2408 to the UCS chassis.

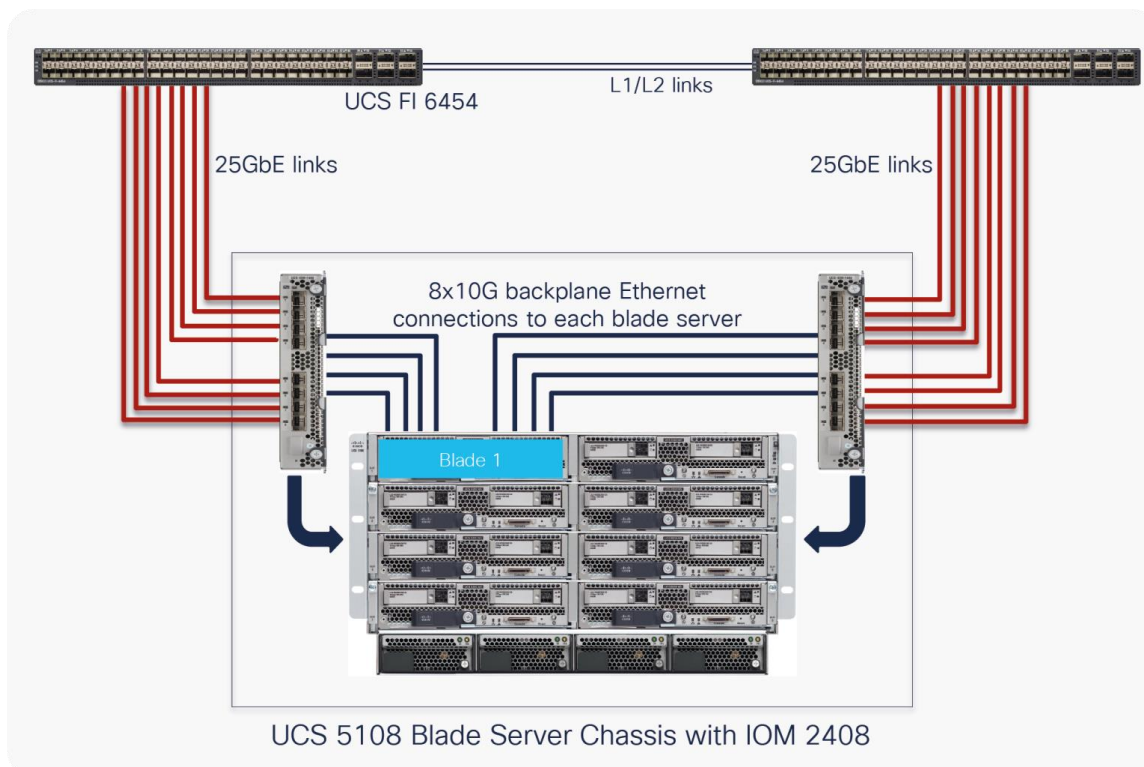
Figure 2.
Cisco UCS 5108 Blade Server Chassis with Cisco UCS I/O Module 2408 and 25GbE links to Cisco UCS Fiber Interconnect 6454

Note: The Figure 2 is applicable for the Cisco UCS Fabric Interconnect 6400 series (6454 and 64108).

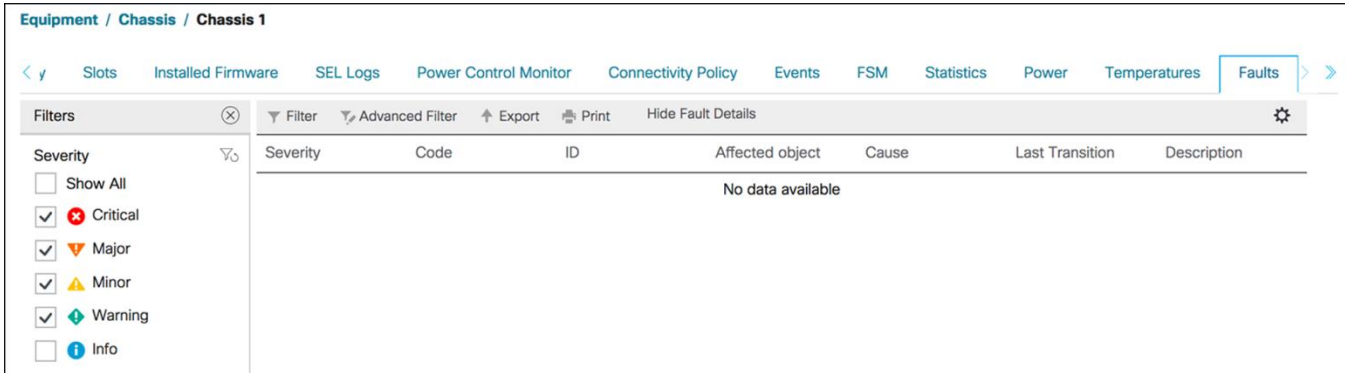
Figure 3.
Fault check on UCS blade server chassis before migration

Step 1: From UCSM, validate that the fiber interconnect cluster high-availability redundancy state is present and there are no faults, and identify the subordinate Fiber Interconnect 6400 series in the UCS domain.

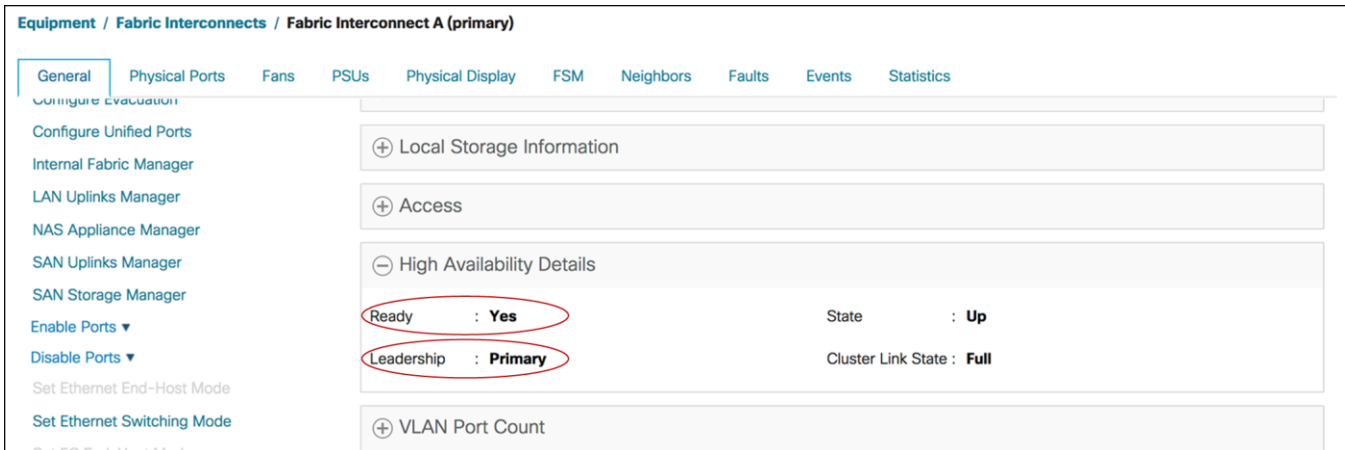
Figure 4.
Cluster high-availability redundancy state

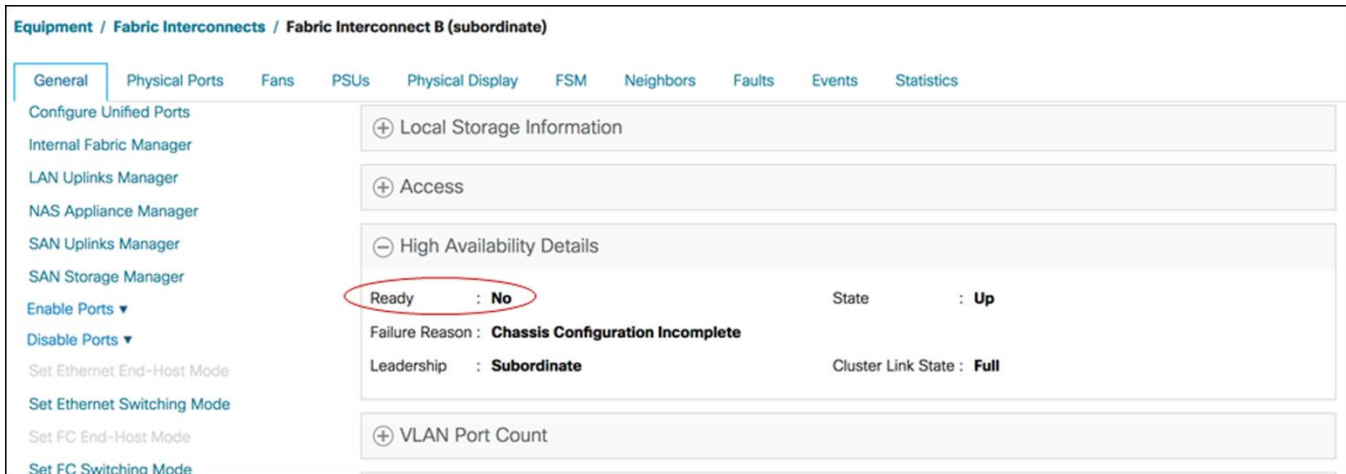
Figure 9. High-availability redundancy state after migrating IOMs toward the subordinate fiber interconnect

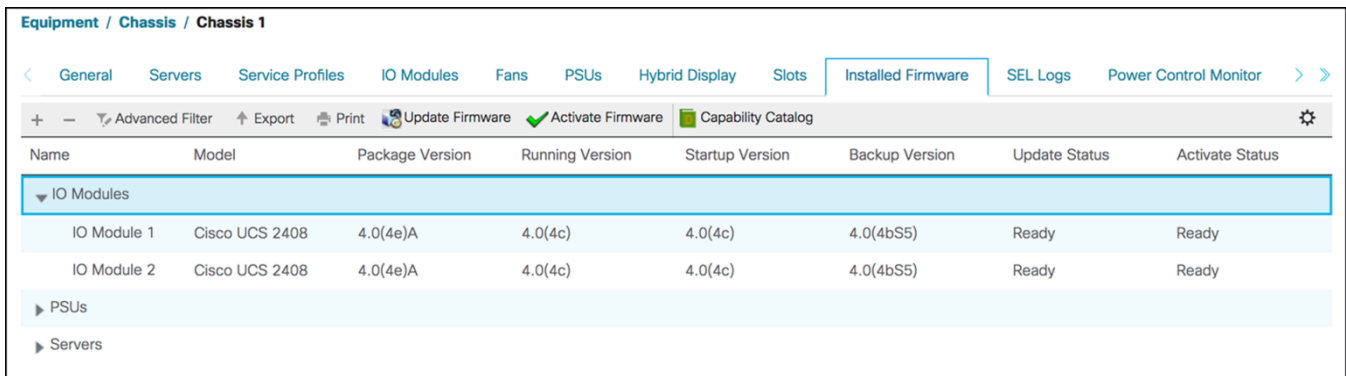
Figure 10. IOM firmware snapshot after migrating both IOMs

Step 10: After completing the IOM 2408 migration on all the UCS 5108 chassis in the domain, verify that cluster high-availability is present on the fabric interconnect, there are no faults on the UCSM, and traffic is forwarding over the new IOM 2408s on both fabric A and B.

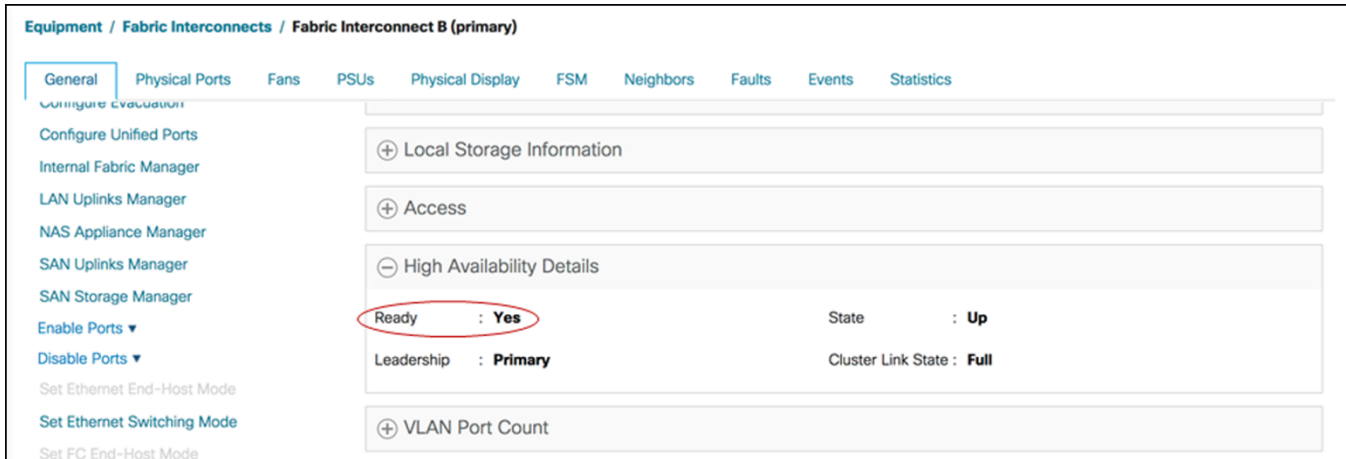
Figure 11.
High-availability redundancy after completing migration
