## **Cisco ONS 15454 Troubleshooting Guide**

Product and Documentation Release 4.6

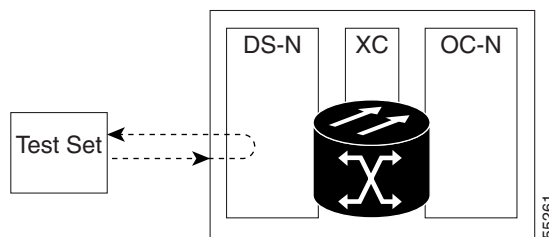
**Figure 1-1 Facility (Line) Loopback Process on a DS-N Card**

A facility (line) loopback tests the line interface unit (LIU) of a card, the EIA (electrical interface assembly), and related cabling. After applying a facility loopback on a port, use a test set to run traffic over the loopback. A successful facility loopback isolates the LIU, the EIA, or the cabling plant as the potential cause of a network problem. [Figure 1-1](#) shows a facility loopback on a DS-N card.

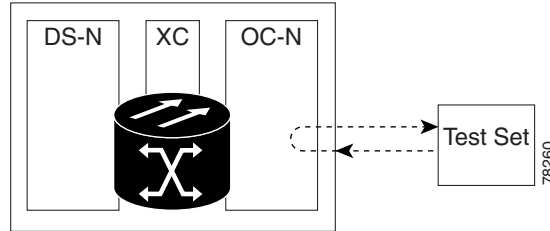
**Figure 1-2 Facility (Line) Loopback Process on an OC-N Card**

To test the LIU on an OC-N card, connect an optical test set to the OC-N port and perform a facility (line) loopback or use a loopback or hairpin circuit on a card that is farther along the circuit path. [Figure 1-2](#) shows a facility loopback on an OC-N card.

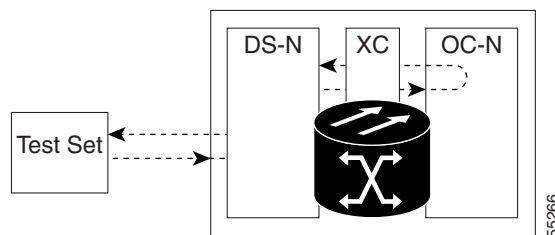
**Figure 1-3 Terminal Loopback Process on an OC-N Card**

A terminal loopback tests a circuit path as it passes through the cross-connect card (XC10G) and loops back from the card with the loopback. [Figure 1-3](#) shows a terminal loopback on an OC-N card. (Ethernet, transponder, and muxponder loopbacks follow the same model.) The test-set traffic comes into the DS-N card and goes through the cross-connect card to the OC-N card. The terminal loopback on the OC-N card turns the signal around before it reaches the LIU and sends it back through the cross-connect card to the DS-N card. This test verifies that the cross-connect card and terminal circuit paths are valid, but does not test the LIU on the OC-N card.

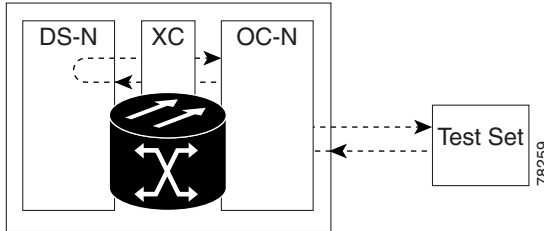
**Figure 1-4 Terminal Loopback Process on a DS-N Card**

Figure 1-4 shows a terminal loopback on a DS-N card. The test-set traffic comes in on the OC-N card and goes through the cross-connect card to the DS-N card. The terminal loopback on the DS-N card turns the signal around before it reaches the LIU and sends it back through the cross-connect card to the OC-N card. This test verifies that the cross-connect card and terminal circuit paths are valid, but does not test the LIU on the DS-N card.

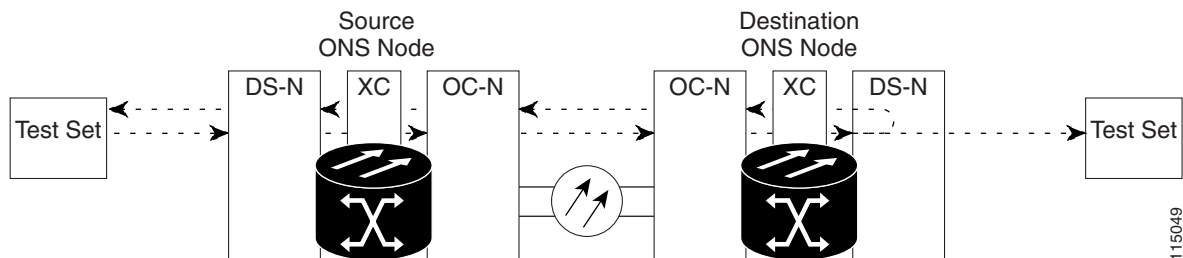
**Figure 1-5 Terminal Loopback on a DS-N Card with Bridged Signal**

Bridged DS-N and OC-N terminal loopback examples are shown in [Figure 1-5](#) and [Figure 1-6](#).

If an optical, electrical, Ethernet, and TXP/MXP port terminates a terminal or facility loopback signal, this means that the signal only loops back to the originating port and is not transmitted downstream. If the port bridges a loopback signal, the signal loops back to the originating port and is also transmitted downstream.

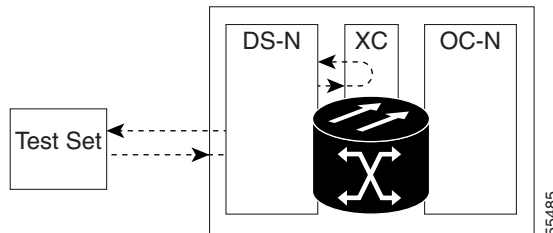
**Figure 1-7 Hairpin Circuit Process on a DS-N Card**

A hairpin circuit brings traffic in and out on a DS-N port rather than sending the traffic onto the OC-N card. A hairpin loops back only the specific STS or VT circuit and does not cause an entire OC-N port to loop back, thus preventing a drop of all traffic on the OC-N port. The hairpin allows you to test a specific STS or VT circuit on nodes running live traffic. Figure 1-9 shows the hairpin circuit process on a DS-N card.

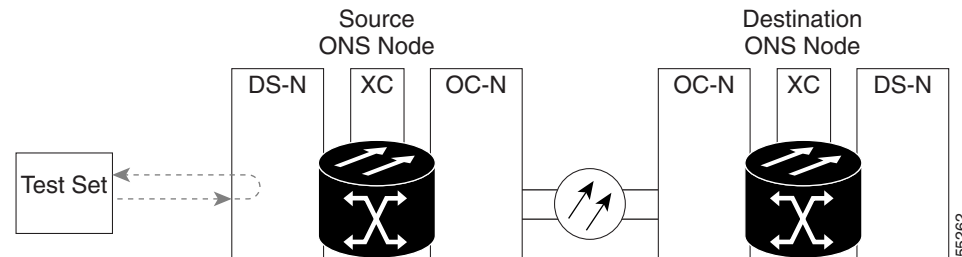
**Figure 1-8 A Facility (Line) Loopback on a Circuit Source DS-N Port**

The facility (line) loopback test is performed on the node source port in the network circuit, in this example, the DS-N port in the source node. Completing a successful facility (line) loopback on this port isolates the cabling, the DS-N card, and the EIA as possible failure points. [Figure 1-10](#) shows an example of a facility loopback on a source DS-N port.

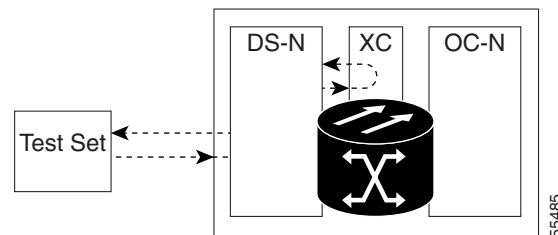
**Figure 1-9 Hairpin Circuit Process on a DS-N Card**

A hairpin circuit brings traffic in and out on a DS-N port rather than sending the traffic onto the OC-N card. A hairpin loops back only the specific STS or VT circuit and does not cause an entire OC-N port to loop back, thus preventing a drop of all traffic on the OC-N port. The hairpin allows you to test a specific STS or VT circuit on nodes running live traffic. [Figure 1-9](#) shows the hairpin circuit process on a DS-N card.

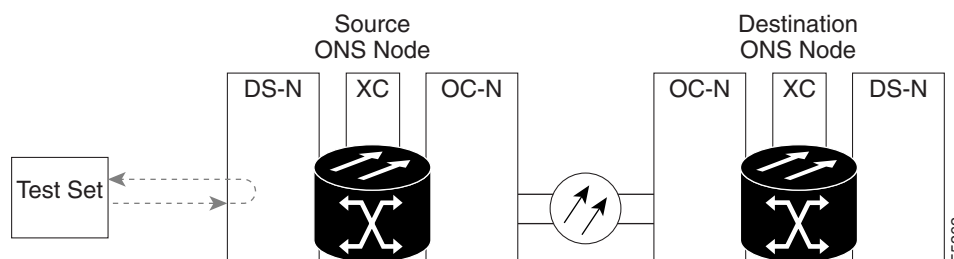
**Figure 1-10 A Facility (Line) Loopback on a Circuit Source DS-N Port**

The facility (line) loopback test is performed on the node source port in the network circuit, in this example, the DS-N port in the source node. Completing a successful facility (line) loopback on this port isolates the cabling, the DS-N card, and the EIA as possible failure points. [Figure 1-10](#) shows an example of a facility loopback on a source DS-N port.

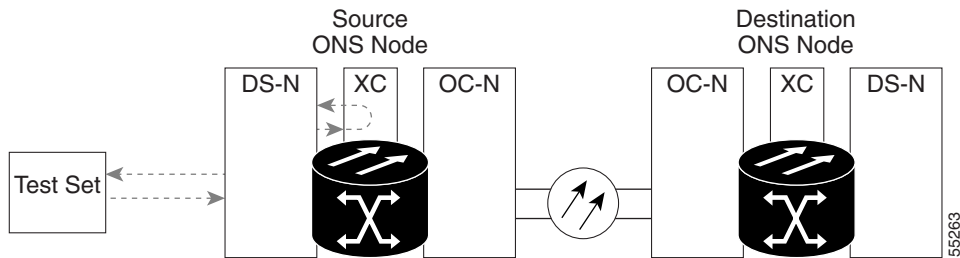
**Figure 1-11** Hairpin on a Source Node Port

The hairpin test is performed on the cross-connect card in the network circuit. A hairpin circuit uses the same port for both source and destination. Completing a successful hairpin through the port isolates the possibility that the cross-connect card is the cause of the faulty circuit. [Figure 1-11](#) shows an example of a hairpin loopback on a source node port.

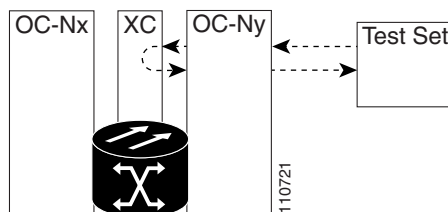
**Figure 1-12** XC Loopback on a Destination OC-N Port

The XC loopback tests whether any problem exists on the circuit’s OC-N span, isolating this span from others present on the card. The loopback occurs on the XC10G cross-connect card in a network circuit. [Figure 1-12](#) shows an example of an XC loopback on a destination OC-N port.

**Note** The XC Loopback on an OC-N card does not affect traffic on other circuits.

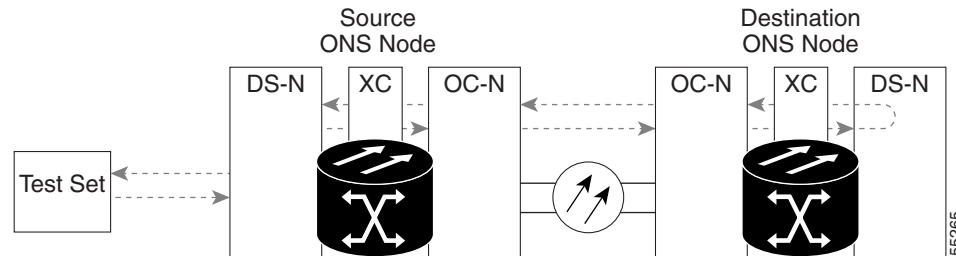
**Figure 1-13 Terminal (Inward) Loopback on a Destination DS-N Port**

Completing a successful terminal loopback to a destination node DS-N port verifies that the circuit is good to the destination DS-N. Figure 1-13 shows an example of a terminal loopback on a destination DS-N port.

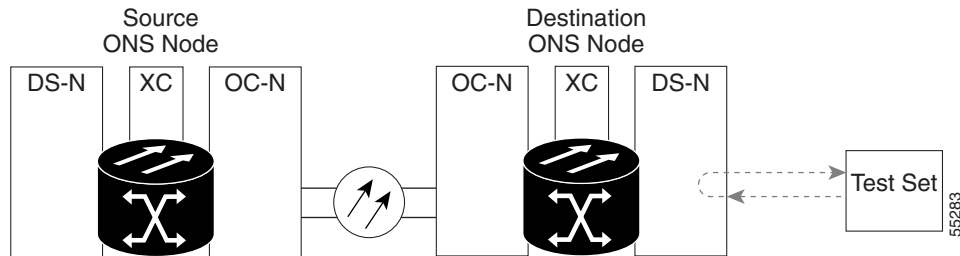
**Figure 1-14 A Facility (Line) Loopback on a Circuit Destination DS-N Port**

The facility (line) loopback test is performed on the node destination port in the network circuit, in this example, the DS-N port in the destination node. Completing a successful facility (line) loopback on this port isolates the cabling, the DS-N card, and the EIA as possible failure points. Figure 1-14 shows an example of a facility loopback on a destination DS-N port.

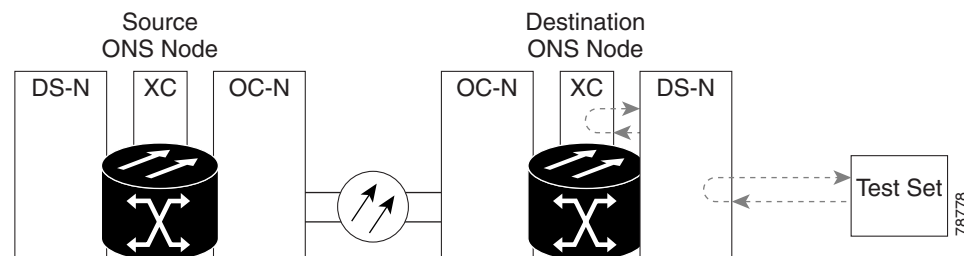
**Figure 1-15 Hairpin on a Destination Node Port**

The hairpin test is performed on the cross-connect card in the network circuit. A hairpin circuit uses the same port for both source and destination. Completing a successful hairpin through the card isolates the possibility that the cross-connect card is the cause of the faulty circuit. [Figure 1-15](#) shows an example of a hairpin loopback on a destination node port.

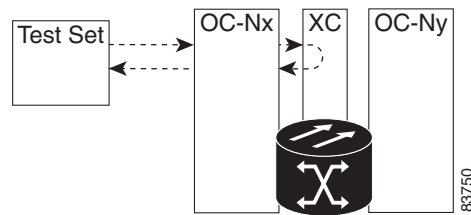
**Figure 1-16** XC Loopback on a Source OC-N Port

The XC loopback tests whether any problem exists on the circuit's OC-N span, isolating this span from others present on the card. It also eliminates the cross-connect card as the source of trouble for a faulty circuit. The loopback occurs on the XC10G cross-connect card in a network circuit. [Figure 1-16](#) shows an example of an XC loopback on a source OC-N port.

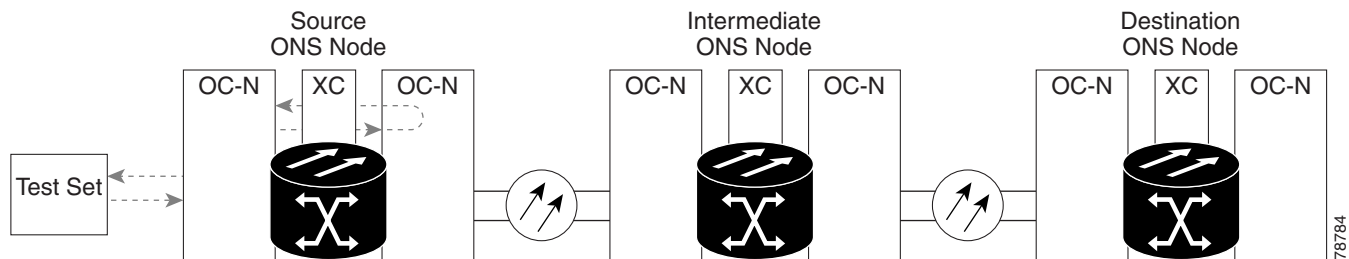
**Figure 1-17 Terminal (Inward) Loopback on a Source DS-N Port**

The terminal (inward) loopback test is performed on the node source port in the circuit, such as a source node DS-N port. You first create a bidirectional circuit that starts on the destination node DS-N port and loops back on the source node DS-N port. Then you proceed with the terminal loopback test. Completing a successful terminal loopback to a source node DS-N port verifies that the circuit is good to the source DS-N. [Figure 1-17](#) shows an example of a terminal loopback on a source DS-N port.

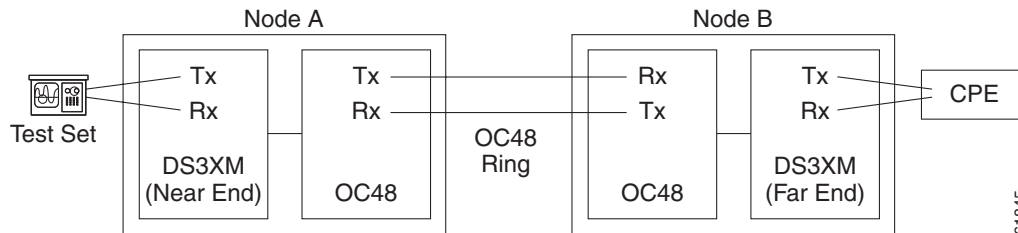
Figure 1-19 Diagram of FEAC

The “far end” in FEAC refers to the equipment connected to the DS3XM-6 card and not to the far end of a circuit. In Figure 1-19, if a DS3XM-6 (near-end) port is configured to send a Line Loop Code, the code will be sent to the connected test set, not the DS3XM-6 (far-end) port.

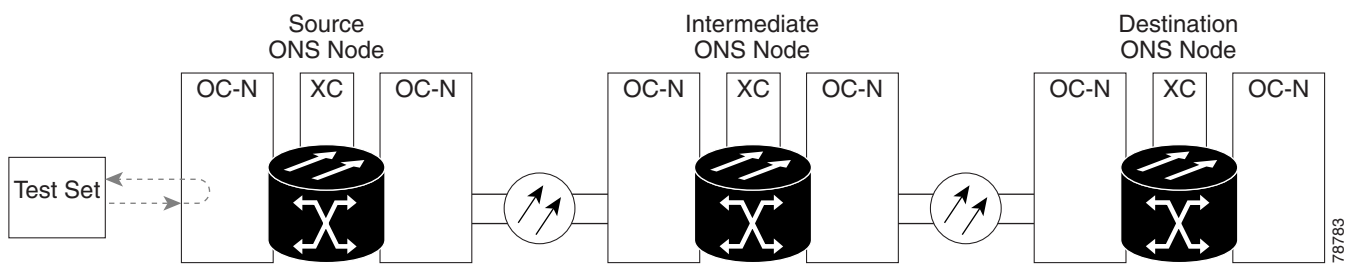
**Figure 1-20 Facility (Line) Loopback on a Circuit Source OC-N Port**

The facility (line) loopback test is performed on the node source port in the network circuit. In the testing situation used in this example, the source OC-N port in the source node. Completing a successful facility (line) loopback on this port isolates the OC-N port as a possible failure point. Figure 1-20 shows an example of a facility loopback on a circuit source OC-N port. G-Series Ethernet ports, TXPs, and MXPs are tested similarly.

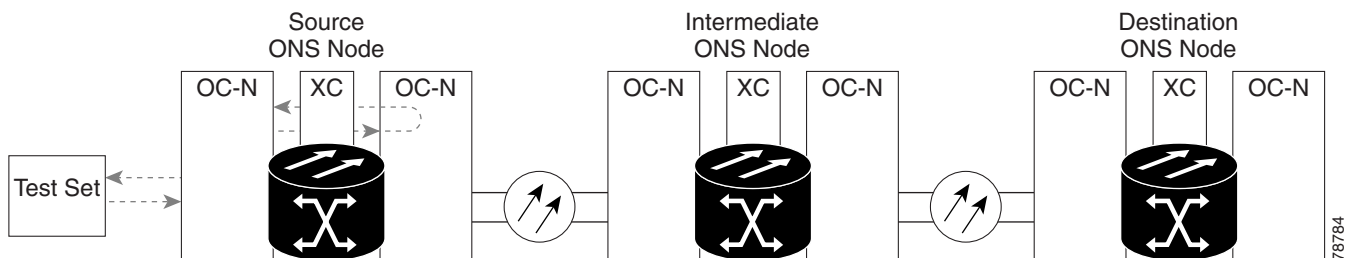
**Figure 1-21 Terminal (Inward) Loopback on a Source-Node OC-N Port**

The terminal (inward) loopback test is performed on the node source OC-N, G-Series, MXP, or TXP port. For the circuit in this example, it is the source OC-N port in the source node. You first create a bidirectional circuit that starts on the node destination OC-N port and loops back on the node source OC-N port. You then proceed with the terminal loopback test. Completing a successful terminal loopback to a node source port verifies that the circuit is good to the source port. [Figure 1-21](#) shows an example of a terminal loopback on a source OC-N port.

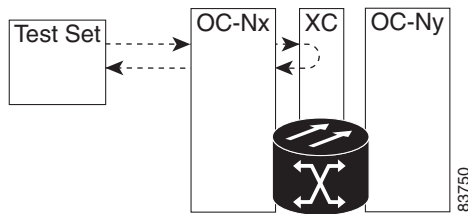
**Figure 1-23** XC Loopback on a Source OC-N Port

The cross-connect (XC) loopback test occurs on the XC10G cross-connect card in a network circuit. Completing a successful XC loopback from an OC-N card through the cross-connect card eliminates the cross-connect card as the source of trouble for a faulty circuit. [Figure 1-23](#) shows an example of an XC loopback on a source OC-N port.

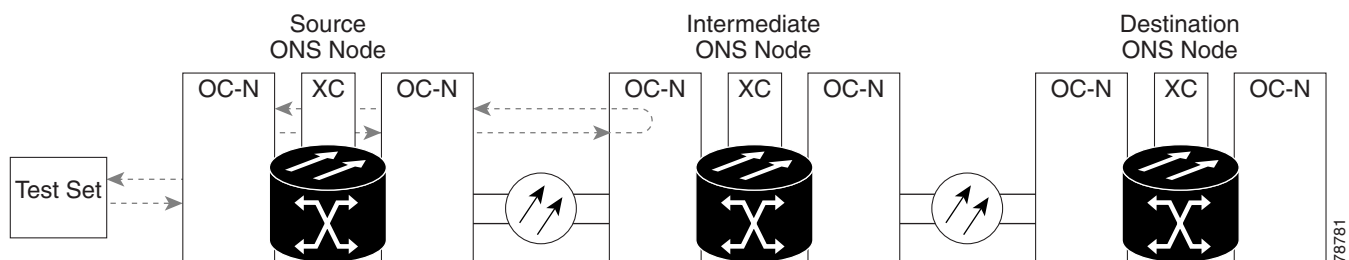
**Figure 1-24 Facility (Line) Loopback on an Intermediate-Node OC-N Port**

Performing the facility (line) loopback test on an intermediate port isolates whether this node is causing circuit failure. In the situation shown in [Figure 1-24](#), the test is being performed on an intermediate OC-N port.

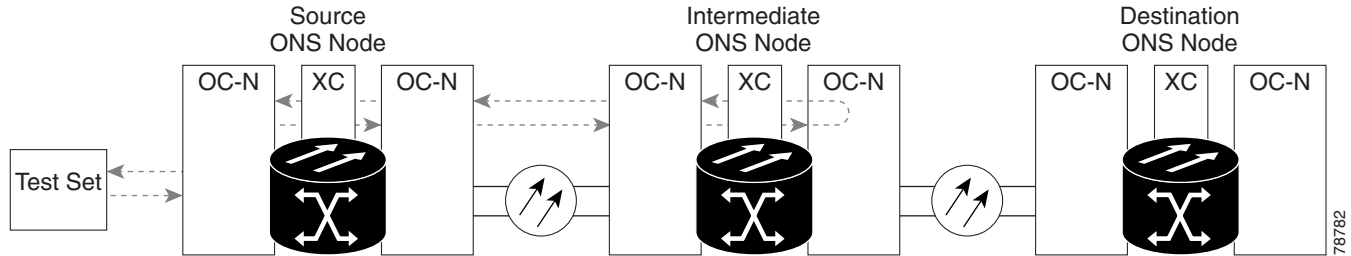
Figure 1-25 Terminal Loopback on an Intermediate-Node OC-N Port

In the next troubleshooting test, you perform a terminal loopback on the intermediate-node port to isolate whether the destination port is causing circuit trouble. In the example situation in [Figure 1-25](#), the terminal loopback is performed on an intermediate OC-N port in the circuit. You first create a bidirectional circuit that originates on the source node OC-N, G-Series, MXP, or TXP port and loops back on the intermediate-node port. You then proceed with the terminal loopback test. If you successfully complete a terminal loopback on the node, this node is excluded from possible sources of circuit trouble.

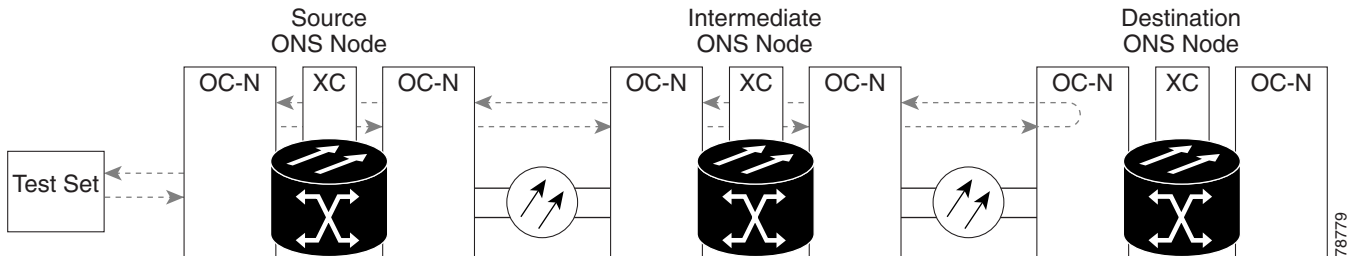
**Figure 1-26 Facility (Line) Loopback on a Destination Node OC-N Port**

You perform a facility (line) loopback test at the destination port to determine whether this local port is the source of circuit trouble. The example in [Figure 1-26](#) shows a facility loopback performed on an OC-N port, but you can also use this procedure on G-Series, MXP, or TXP cards.

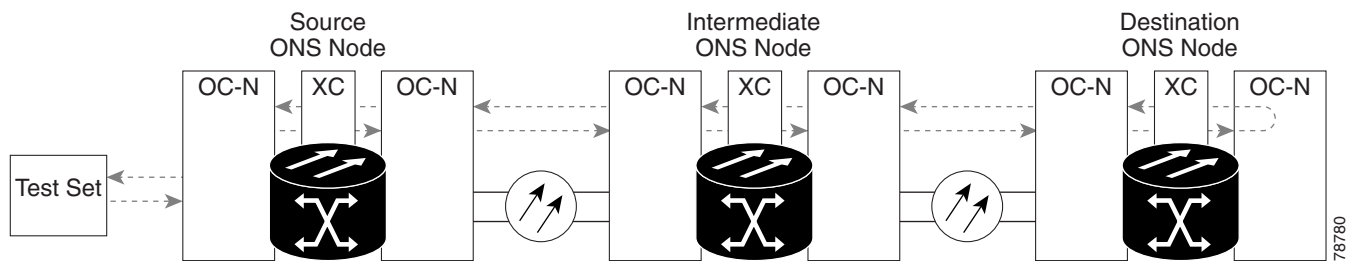
Figure 1-27 Terminal Loopback on a Destination Node OC-N Port

The terminal loopback at the destination node port is the final local hardware error elimination in the circuit troubleshooting process. If this test is completed successfully, you have verified that the circuit is good up to the destination port. The example in Figure 1-27 shows a terminal loopback on an intermediate node destination OC-N port.

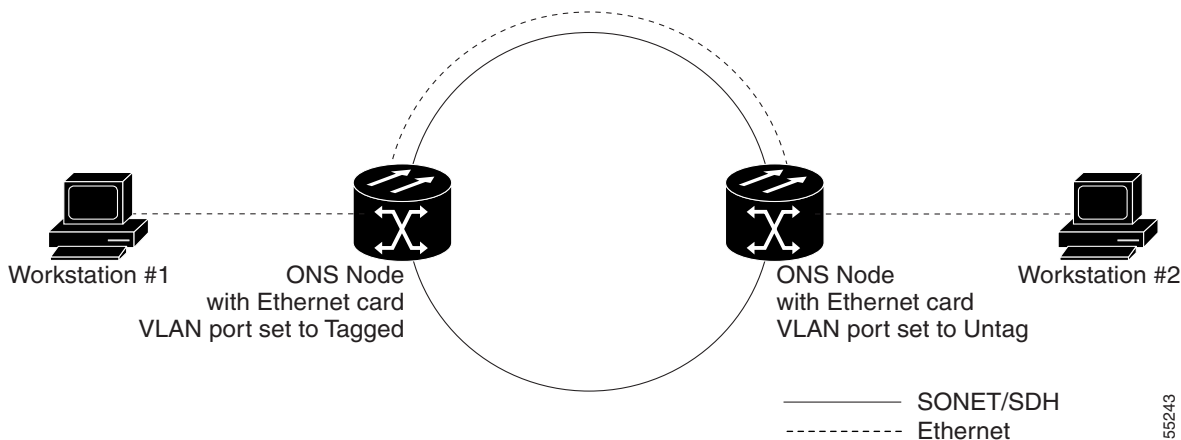
Figure 1-32 VLAN with Ethernet Ports at Tagged and Untag

**Symptom** Networks that have a VLAN with one ONS 15454 Ethernet card port set to Tagged and one ONS 15454 Ethernet card set to Untag might have difficulty implementing Address Resolution Protocol (ARP) for a network device attached to the Untag port (Figure 1-32). They might also see a higher than normal runt packets count at the network device attached to the Untag port. This symptom/limitation also exists when ports within the same card or ports within the same chassis are put on the same VLAN, with a mix of tagged and untagged.

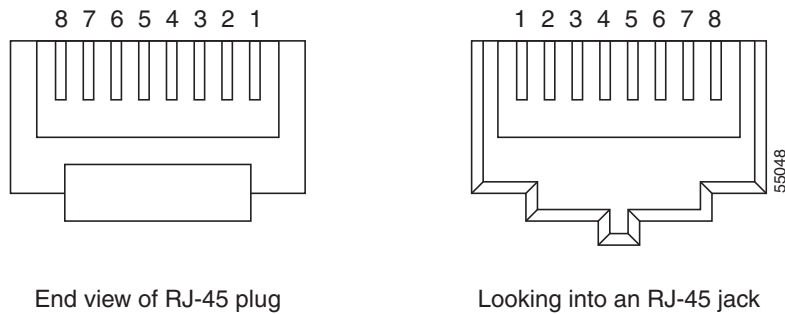
**Figure 1-34 RJ-45 Pin Numbers**

You can crimp your own LAN cables for use with the ONS 15454. Use a cross-over cable when connecting an ONS 15454 to a hub, LAN modem, or switch, and use a LAN cable when connecting an ONS 15454 to a router or workstation. Use CAT-5 cable RJ-45 T-568B, Color Code (100 Mbps), and a crimping tool. [Figure 1-34](#) shows the wiring of an RJ-45 connector. [Figure 1-35](#) shows a LAN cable layout, and [Table 1-40](#) shows the cable pinouts. [Figure 1-36](#) shows a cross-over cable layout, and [Table 1-41](#) shows the cross-over pinouts.

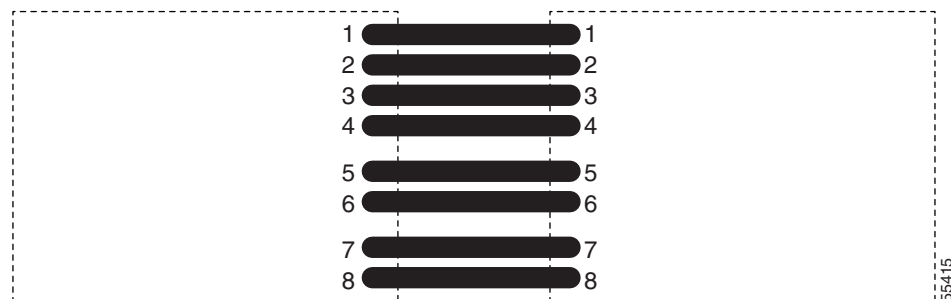
**Figure 1-35 LAN Cable Layout**

Pin	Color	Pair	Name	Pin
1	white/orange	2	Transmit Data +	1
2	orange	2	Transmit Data —	2
3	white/green	3	Receive Data +	3
4	blue	1	—	4
5	white/blue	1	—	5
6	green	3	Receive Data —	6
7	white/brown	4	—	7
8	brown	4	—	8

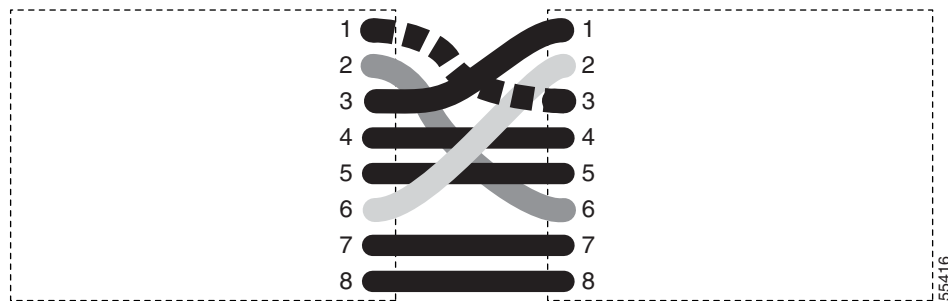
**Figure 1-36 Cross-Over Cable Layout**

Pin	Color	Pair	Name	Pin
1	white/orange	2	Transmit Data +	3
2	orange	2	Transmit Data —	6
3	white/green	3	Receive Data +	1
4	blue	1	—	4
5	white/blue	1	—	5
6	green	3	Receive Data —	2
7	white/brown	4	—	7
8	brown	4	—	8

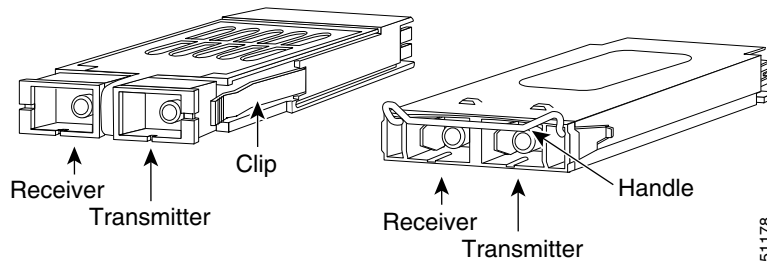
**Figure 1-37 GBICs**

GBICs are available in two different models. One GBIC model has two clips (one on each side of the GBIC) that secure the GBIC in the slot on the E1000-2-G, G-Series, or G1K-4 card. The other model has a locking handle. Both models are shown in [Figure 1-37](#).

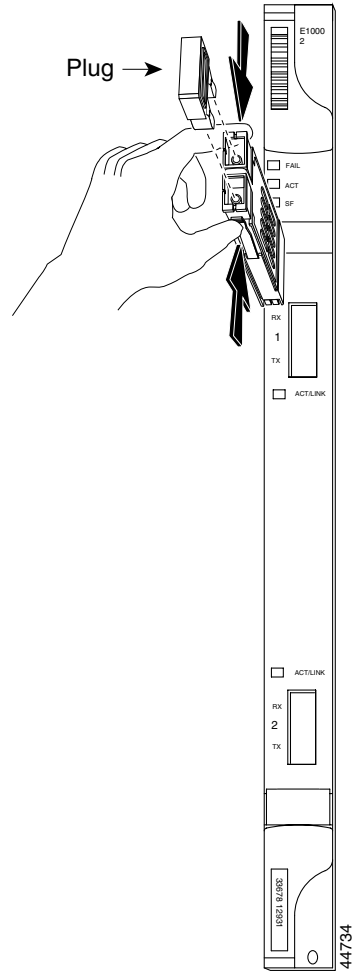
**Figure 1-38 GBIC Installation (with Clips)**

- Step 1** Remove the GBIC from its protective packaging.
- Step 2** Check the label to verify that the GBIC is the correct type (SX, LX, or ZX) for your network.
- Step 3** Verify that you are installing compatible GBICs; for example, SX to SX, LX to LX, or ZX to ZX.
- Step 4** Grip the sides of the GBIC with your thumb and forefinger and insert the GBIC into the slot on the E1000-2, E1000-2-G, or G-Series card (Figure 1-38).

- Step 5** Slide the GBIC through the flap that covers the opening until you hear a click. The click indicates the GBIC is locked into the slot.
- Step 6** When you are ready to attach the network fiber-optic cable, remove the protective plug from the GBIC and save the plug for future use.
- Step 7** Return to your originating procedure (NTP).

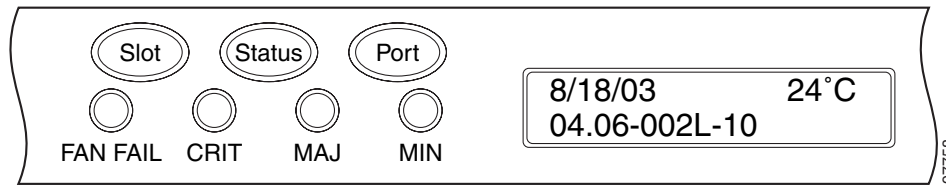
**Figure 2-1 Shelf LCD Panel**

- Step 1** View the temperature displayed on the ONS 15454 LCD front panel ([Figure 2-1](#)).

- Step 1** View the temperature displayed on the ONS 15454 LCD front panel ([Figure 2-1 on page 2-35](#)).
- Step 2** Verify that the environmental temperature of the room is not abnormally high.
- Step 3** If the room temperature is not abnormal, physically ensure that nothing prevents the fan-tray assembly from passing air through the ONS 15454.
- Step 4** If airflow is not blocked, physically ensure that blank faceplates fill the ONS 15454 empty slots. Blank faceplates help airflow.
- Step 5** If faceplates fill the empty slots, determine whether the air filter needs replacement. Refer to the [“Inspect, Clean, and Replace the Reusable Air Filter” procedure on page 3-5](#).
- Step 6** If the filter is clean, complete the [“Remove and Reinsert Fan-Tray Assembly” procedure on page 2-220](#).

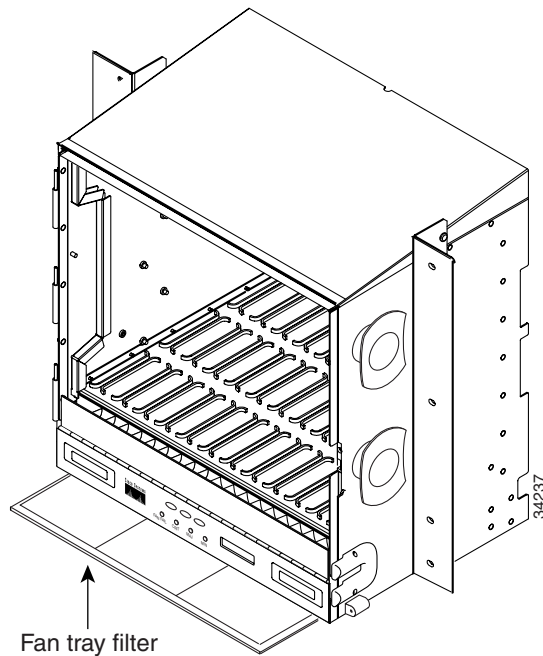
**Figure 3-1 Reusable Fan-Tray Air Filter in an External Filter Bracket (Front Door Removed)**

- Step 2** If the air filter is installed in the external filter brackets, slide the filter out of the brackets while being careful not to dislodge any dust that might have collected on the filter and proceed to [Step 3](#). [Figure 3-1](#) illustrates a reusable fan-tray air filter in an external filter bracket. If the filter is installed beneath the fan tray and not in the external filter brackets:

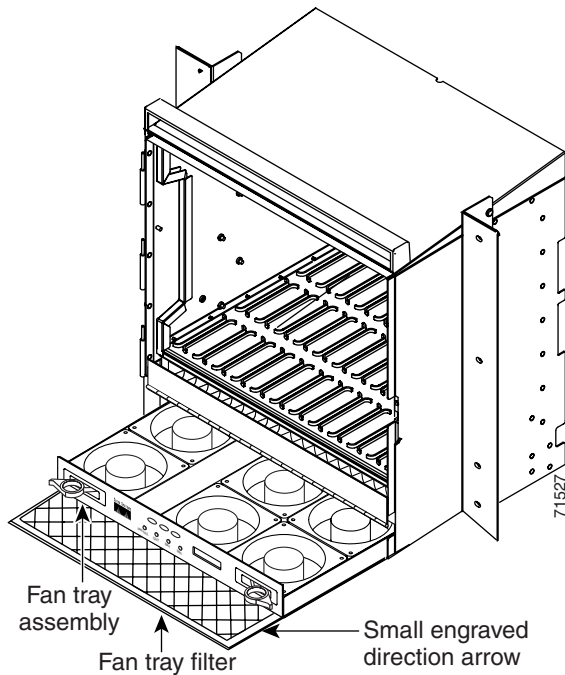
**Figure 3-2** Inserting or Removing the Fan-Tray Assembly (Front Door Removed)

- Step 5** Pull the handles and slide the fan-tray assembly one inch (25.4 mm) out of the shelf assembly and wait until the fans stop.
- Step 6** When the fans have stopped, pull the fan-tray assembly completely out of the shelf assembly ([Figure 3-2](#)).

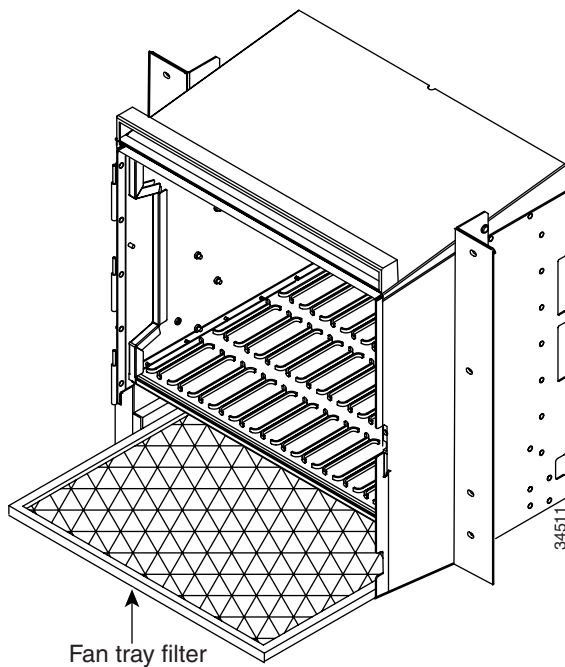
**Figure 3-3** Inserting or Removing a Disposable Fan-Tray Air Filter (Front Door Removed)

- Step 7** Gently remove the air filter from the shelf assembly (Figure 3-3). Be careful not to dislodge any dust that might have collected on the filter.

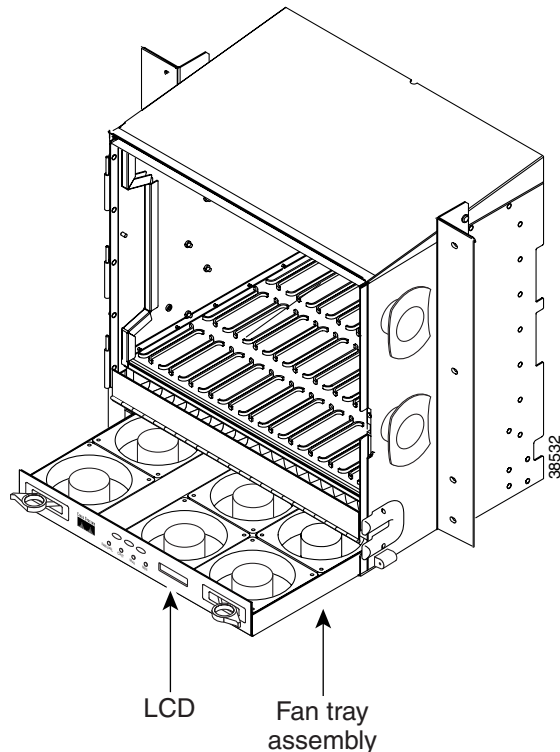
Figure 3-4 Removing or Replacing the Fan-Tray Assembly (Front Door Removed)

- Step 6** When the fans have stopped, pull the fan-tray assembly completely out of the shelf assembly. [Figure 3-4](#) shows the location of the fan tray.

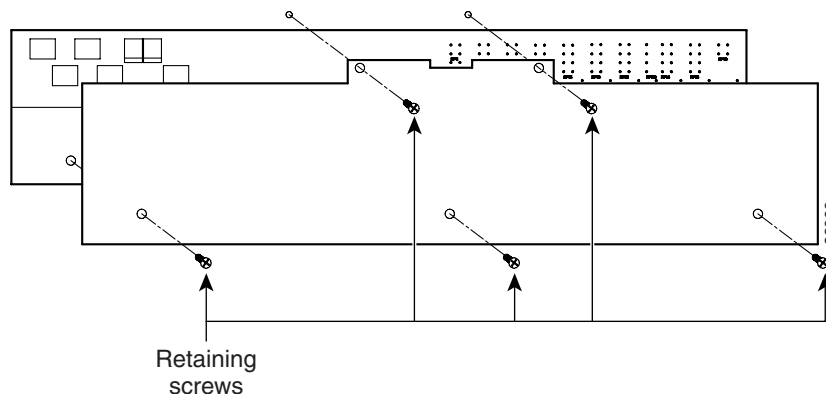
Figure 3-6 Lower Backplane Cover

- Step 3** Call Cisco TAC (1 800 553-2447) for assistance in replacing the AIP and maintaining the original MAC address.
- Step 4** Unscrew the five screws that hold the lower backplane cover in place (Figure 3-6).

- Step 5** Grip the lower backplane cover and gently pull it away from the backplane.
- Step 6** Unscrew the two screws that hold the AIP cover in place.
- Step 7** Grip the cover and gently pull away from the backplane.

**Step 1** To remove the lower backplane cover, loosen the five screws that secure it to the ONS 15454 and pull it away from the shelf assembly (Figure 3-6 on page 3-14).

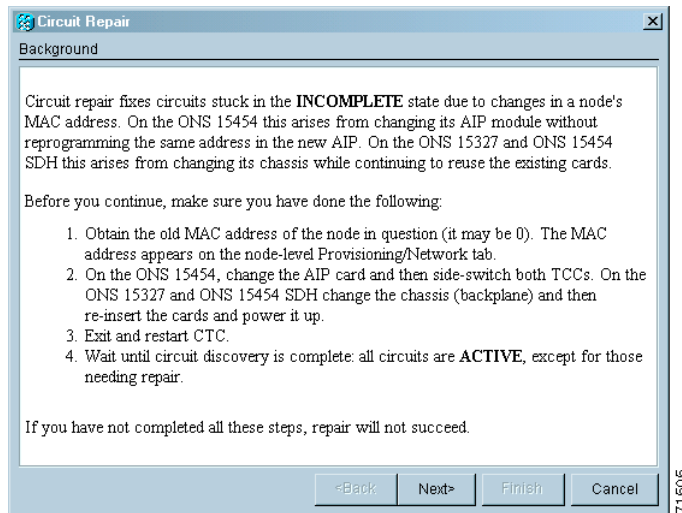
**Figure 3-7** Repairing Circuits

- b. Record the MAC address shown in the General tab.
- Step 21** In node view, click the **Circuits** tab. Note that all circuits listed are in an INCOMPLETE state.
- Step 22** In node view, choose **Repair Circuits** from the **Tools** drop-down menu. The Circuit Repair dialog box appears.
- Step 23** Read the instructions in the Circuit Repair dialog box (Figure 3-7). If all the steps in the dialog box have been completed, click **Next>**. Ensure that you have the old and new MAC addresses.

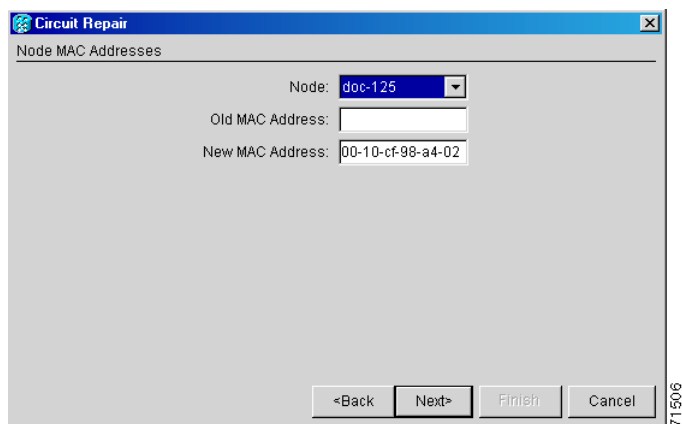
**Figure 3-8** Recording the Old MAC Address Before Replacing the AIP

- Step 24** The Node MAC Addresses dialog box appears (Figure 3-8):
- a. From the Node drop-down menu, choose the name of the node where you replaced the AIP.
  - b. In the Old MAC Address field, enter the old MAC address that was recorded in [Step 2](#).
  - c. Click **Next**.

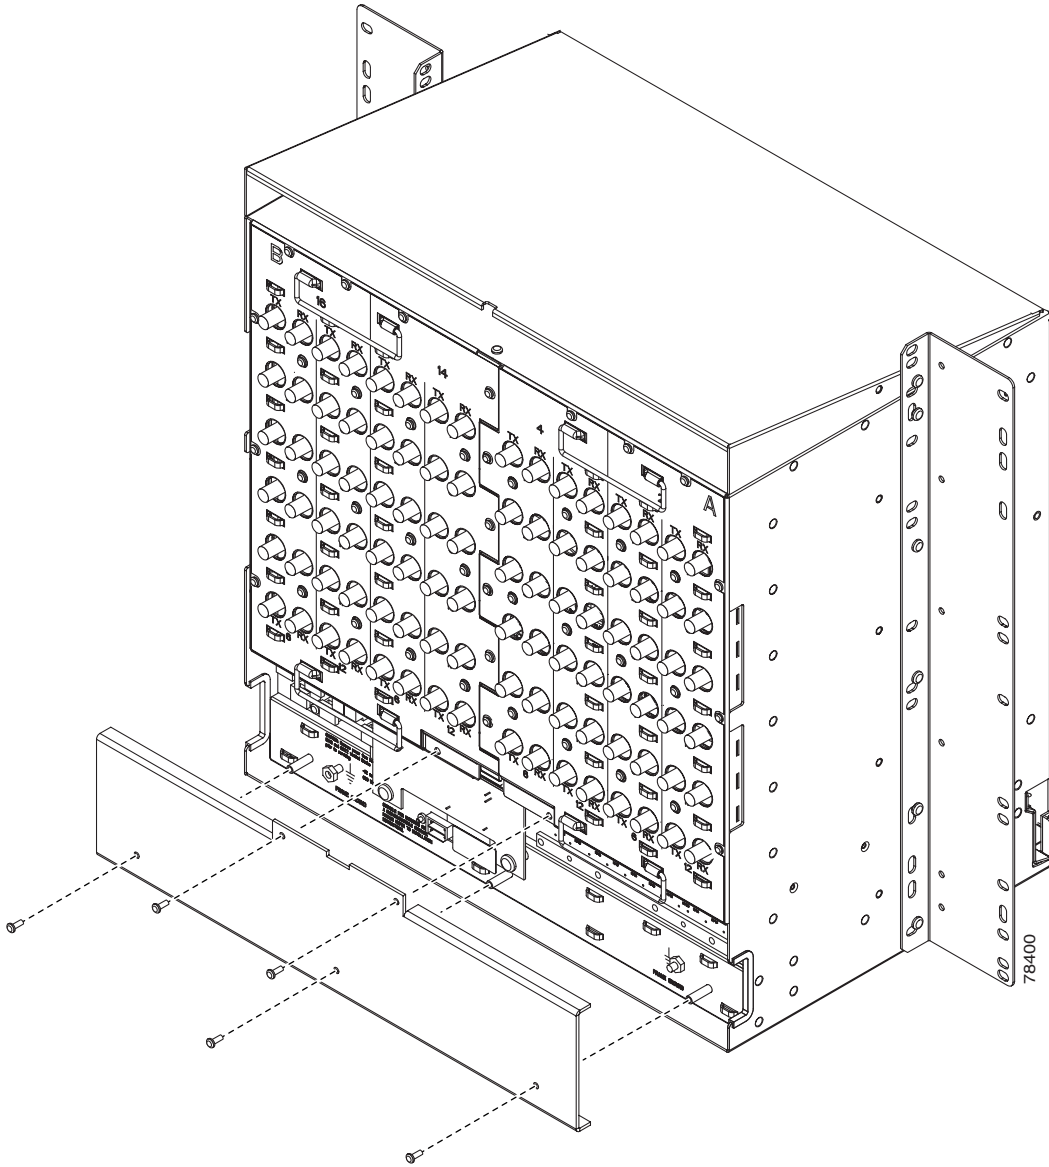
Figure 3-10 Attaching Plastic Lower Backplane Cover

- 
- Step 1** Unscrew the five retaining screws that hold the metal cover in place.
  - Step 2** Grasp the metal cover on each side.
  - Step 3** Gently pull the metal cover away from the backplane.
  - Step 4** Place the plastic cover against the shelf assembly and align the screw holes on the cover and the shelf assembly ([Figure 3-10](#)).

**Step 5** Tighten the five retaining screws that hold the plastic cover in place.

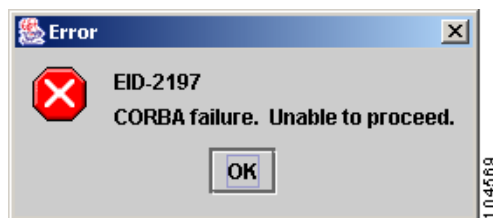
**Figure 4-1** Error Dialog Box

The error dialog box in [Figure 4-1](#) consists of three parts: the error title, error ID, and the error message.
