Alarm Troubleshooting

This chapter gives a description, severity, and troubleshooting procedure for each commonly encountered Cisco ONS 15454 alarm and condition. Tables 2-1 through 2-5 provide lists of ONS 15454 alarms organized by severity. Table 2-6 on page 2-9 provides a list of alarms organized alphabetically. Table 2-7 gives definitions of all ONS 15454 alarm logical objects, which are the basis of the alarm profile list in Table 2-8 on page 2-19. For a comprehensive list of all conditions and instructions for using TL1 commands, refer to the *Cisco SONET TL1 Command Guide*.

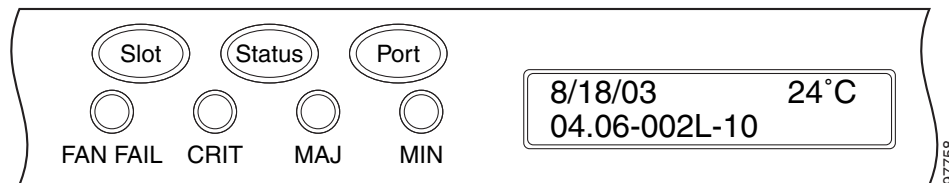
Figure 2-1 Shelf LCD Panel

- Step 1** View the temperature displayed on the ONS 15454 LCD front panel (Figure 2-1).

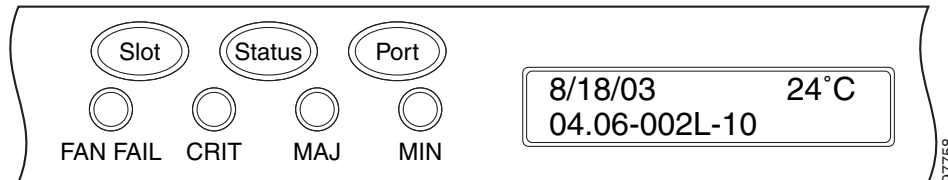
**Figure 2-2 Shelf LCD Panel**

- Step 1** View the temperature displayed on the ONS 15454 LCD front panel (Figure 2-2).

- 
- Step 1** Check for any outstanding alarms that were raised against the active and standby TCC2/TCC2P and resolve them.
- Step 2** If the alarm does not clear, determine whether the LCD display on the fan tray ([Figure 2-2 on page 2-115](#)) is blank or if the text is garbled. If so, proceed to [Step 8](#). If not, continue with [Step 3](#).
- Step 3** At the earliest maintenance window, reset the standby TCC2/TCC2P:
