Alarm Troubleshooting

This chapter gives a description, severity, and troubleshooting procedure for each commonly encountered dense wavelength division multiplexing (DWDM) alarm and condition—whether for trunk or client—used in the Cisco ONS platforms. Tables 2-1 through 2-5 provide lists of DWDM alarms organized by severity. Table 2-6 on page 2-5 provides a list of alarms organized alphabetically. Table 2-7 gives definitions of all DWDM alarm logical objects, which are the basis of the alarm profile list in Table 2-8 on page 2-9.

2.1 Alarm Indexes by Default Severity

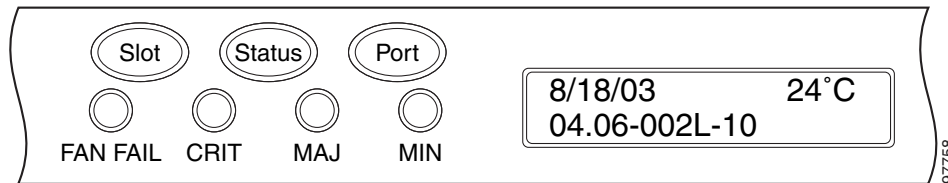
Figure 2-1 Shelf LCD Panel

- Step 1** View the temperature displayed on the ONS system LCD front panel. For example, the ONS 15454 front panel is illustrated in [Figure 2-1](#).

-
- Step 1** Check for any outstanding alarms that were raised against the active and standby TCC2/TCC2P and resolve them.
- Step 2** If the alarm does not clear, determine whether the LCD display on the fan tray ([Figure 2-1 on page 2-53](#)) is blank or if the text is garbled. If so, proceed to [Step 8](#). If not, continue with [Step 3](#).
- Step 3** At the earliest maintenance window, reset the standby TCC2/TCC2P:
