Alarm Troubleshooting

This chapter gives a description, severity, and troubleshooting procedure for each commonly encountered Cisco ONS 15454 alarm and condition. Tables 2-1 through 2-5 provide lists of ONS 15454 alarms organized by severity. Table 2-6 on page 2-11 provides a list of alarms organized alphabetically. Table 2-7 gives definitions of all ONS 15454 alarm logical objects, which are the basis of the alarm profile list in Table 2-8 on page 2-23. For a comprehensive list of all conditions and instructions for using TL1 commands, refer to the *Cisco ONS SONET TL1 Command Guide*.

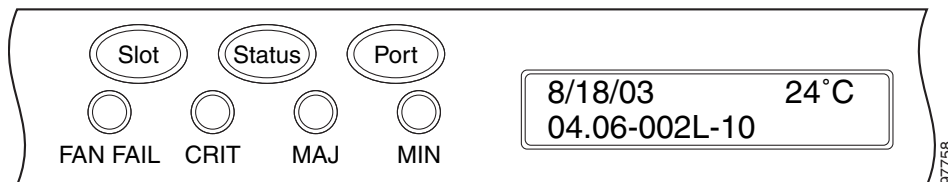
Figure 2-1 Shelf LCD Panel

- Step 1** View the temperature displayed on the ONS 15454 LCD front panel ([Figure 2-1](#)).
