CHAPTER 2

Alarm Troubleshooting

This chapter gives a description, severity, and troubleshooting procedure for each commonly encountered Cisco DWDM alarm and condition. Tables 2-1 through 2-5 provide lists of DWDM alarms organized by severity. Table 2-6 on page 2-8 provides a list of alarms organized alphabetically. Table 2-7 gives definitions of all DWDM alarm logical objects, which are the basis of the alarm profile list in Table 2-8 on page 2-16. For a comprehensive list of all conditions and instructions for using TL1 commands, refer to the *Cisco ONS SONET TL1 Command Guide*.

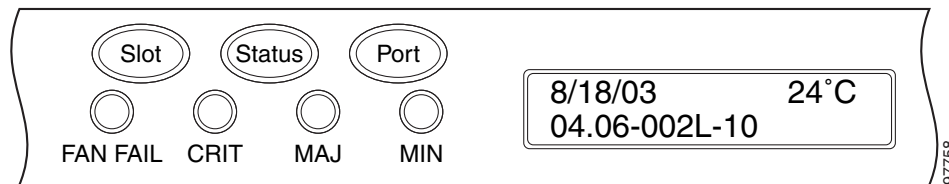
Figure 2-1 Shelf LCD Panel

Step 1 View the temperature displayed on the ONS 15454 LCD front panel (Figure 2-2).

Figure 2-2 shows the shelf LCD panel.
