CHAPTER 2

Alarm Troubleshooting

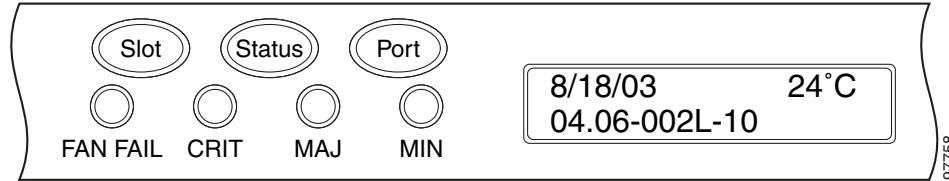
Figure 2-2 Shelf LCD Panel

- 
- Step 1** View the temperature displayed on the ONS system LCD front panel. For example, the ONS 15454 front panel is illustrated in [Figure 2-2](#).

- Step 2** Verify that the environmental temperature of the room is not abnormally high.
- Step 3** If the room temperature is not abnormal, physically ensure that nothing prevents the fan-tray assembly from passing air through the ONS system shelf.
- Step 4** If airflow is not blocked, physically ensure that blank faceplates fill the ONS system shelf empty slots. Blank faceplates help airflow.
- Step 5** If faceplates fill the empty slots, determine whether the air filter needs replacement. Refer to the [“Inspect, Clean, and Replace the Reusable Air Filter” procedure on page 2-247](#).
- Step 6** If the fan does not run or the alarm persists, complete the [“Replace the Fan-Tray Assembly” procedure on page 2-249](#).

- Step 1** Check for any outstanding alarms that were raised against the active and standby TCC2/TCC2P card and resolve them.
- Step 2** If the alarm does not clear, determine whether the LCD display on the fan tray ([Figure 2-2 on page 2-101](#)) is blank or if the text is garbled. If so, proceed to [Step 8](#). If not, continue with [Step 3](#).
- Step 3** At the earliest maintenance window, reset the standby TCC2/TCC2P card:
