Preface

General Troubleshooting

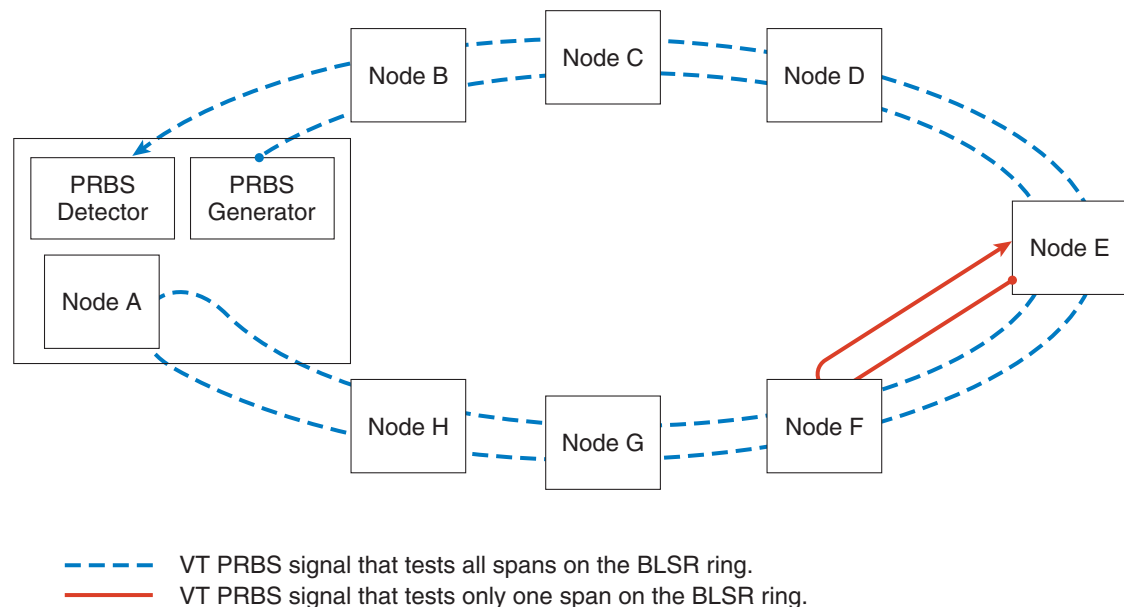
Figure 1-45 CTC Node View Diagnostic Window

The diagnostic circuit can be configured for an end-to-end or multiple-node path layout, traversing the transmit and receive standby paths as shown in Figure 1-45.

NOTE: The end without the arrow is where the PRBS pattern is generated. The end with the arrow is the end where the PRBS pattern is detected.
