Cisco ONS 15454 DWDM Troubleshooting Guide, Release 9.8

First Published: June 12, 2013

Text Part Number: 78-21192-01

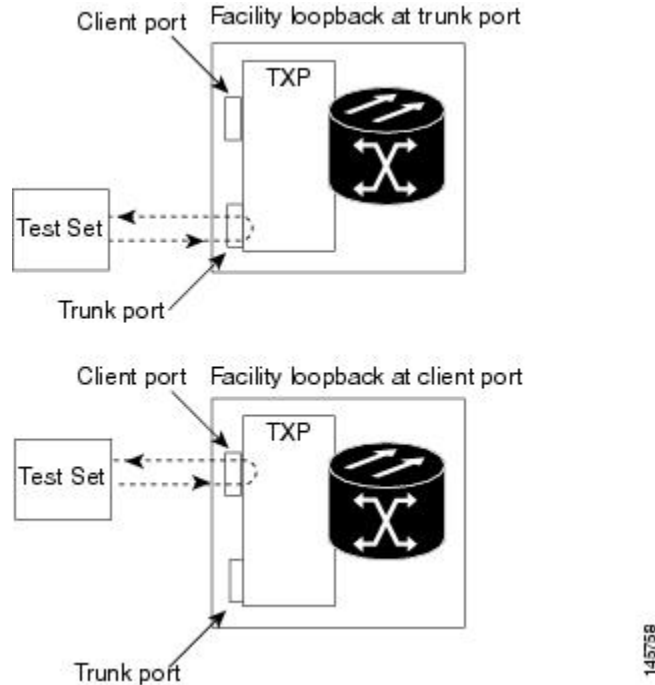
Figure 1: Facility Loopback Path on a Near-End Transponder Card

Figure 1: Facility Loopback Path on a Near-End Transponder Card, on page 3 shows a facility loopback at a trunk port and at a client port on a TXP card.

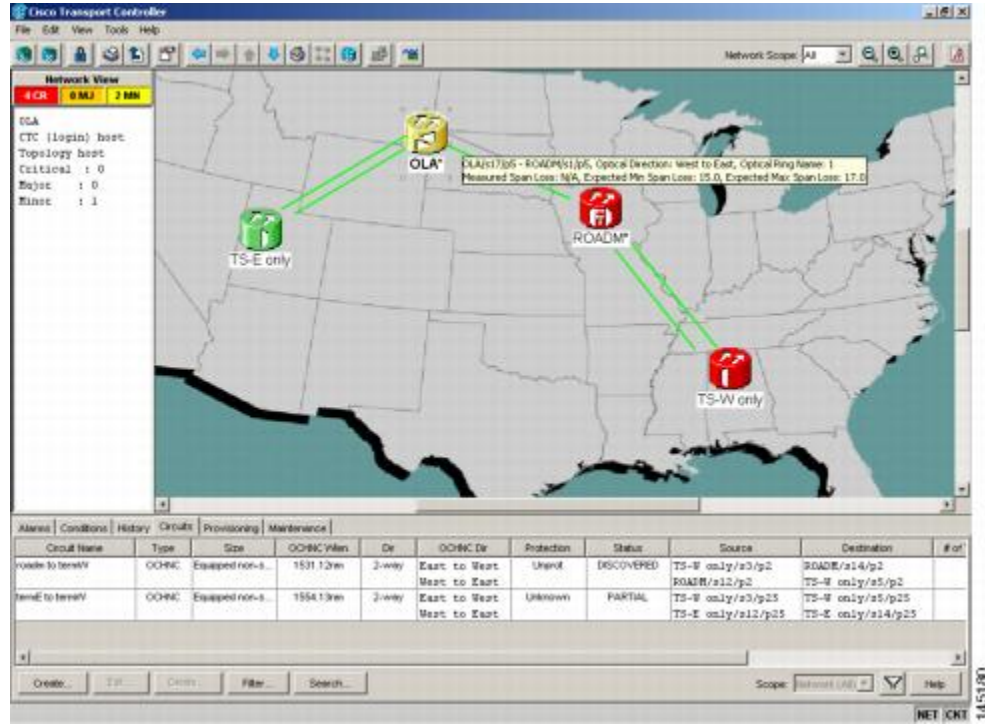
Figure 18: Network View Fault Condition for Fiber Cut with ALS Mode Disabled

The LOS (OTS or AOTS) alarm is raised by the ROADM-RX node that was receiving the signal coming from the broken fiber. The final fault condition of the network is shown in [Figure 18: Network View Fault Condition for Fiber Cut with ALS Mode Disabled](#), on page 69.

In network view ([Figure 18: Network View Fault Condition for Fiber Cut with ALS Mode Disabled](#), on page 69), only the actual affected fiber becomes gray, whereas the traffic (and OSC signal as well) on the good fiber is active and fault identification is immediate.

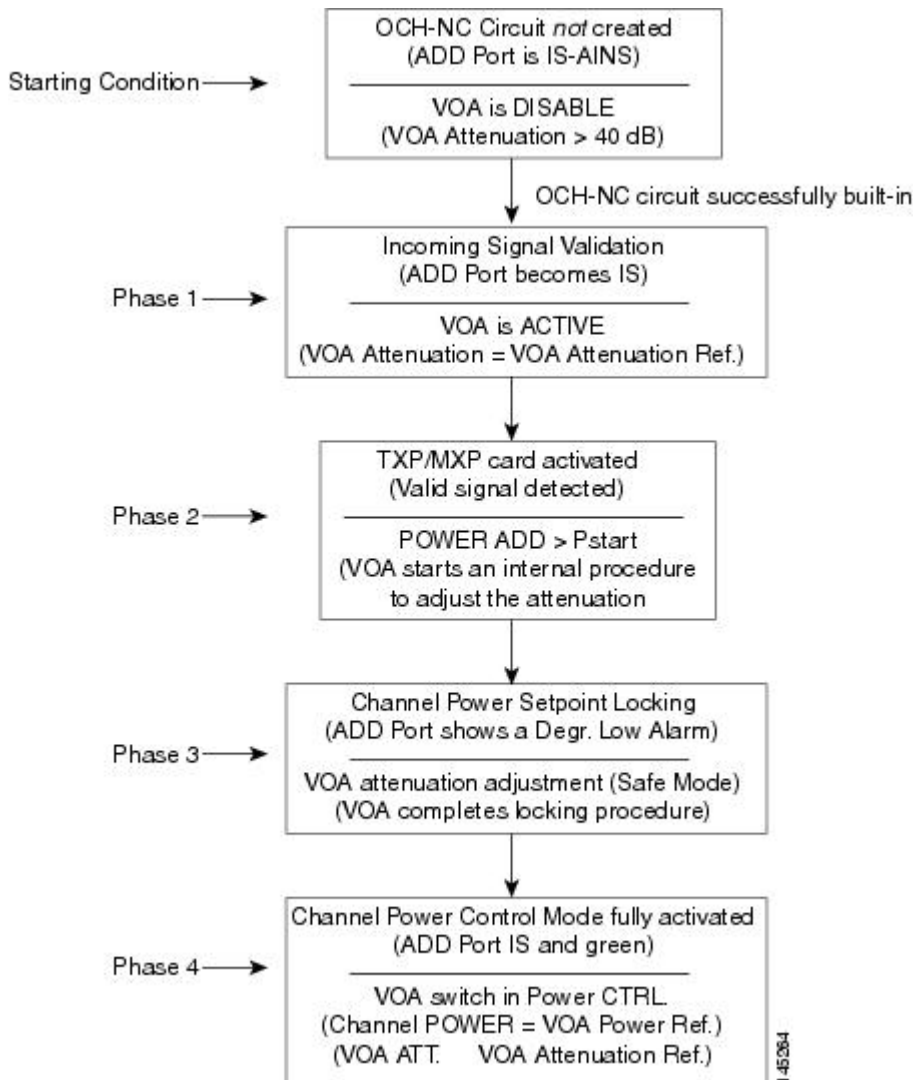
Figure 25: VOA Startup Procedure

The final VOA condition is achieved through a startup procedure divided into the four sequential phases shown in [Figure 25: VOA Startup Procedure](#), on page 86.

Until the VOA has completed all the phases shown in [Figure 25: VOA Startup Procedure](#), on page 86, the power control mode is not fully activated.
