Troubleshooting Guide for Cisco NCS 1010, IOS XR Releases 7.11.x and 24.2.x

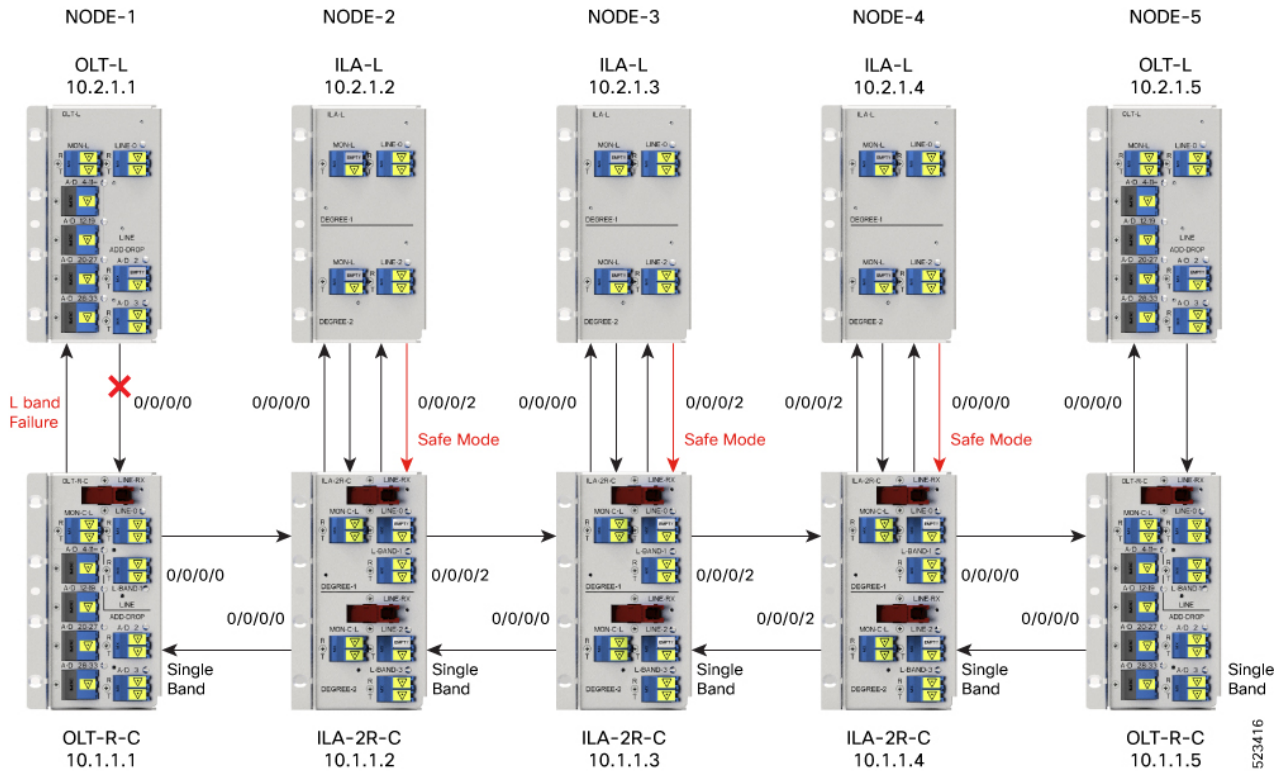
Figure 1: Example of L-band Failure

In this section, we will troubleshoot L band failure due to connectivity failure between OLT-C and OLT-L nodes. To troubleshoot L-band failure on a C+L band network, start by running the following commands on the manager nodes:

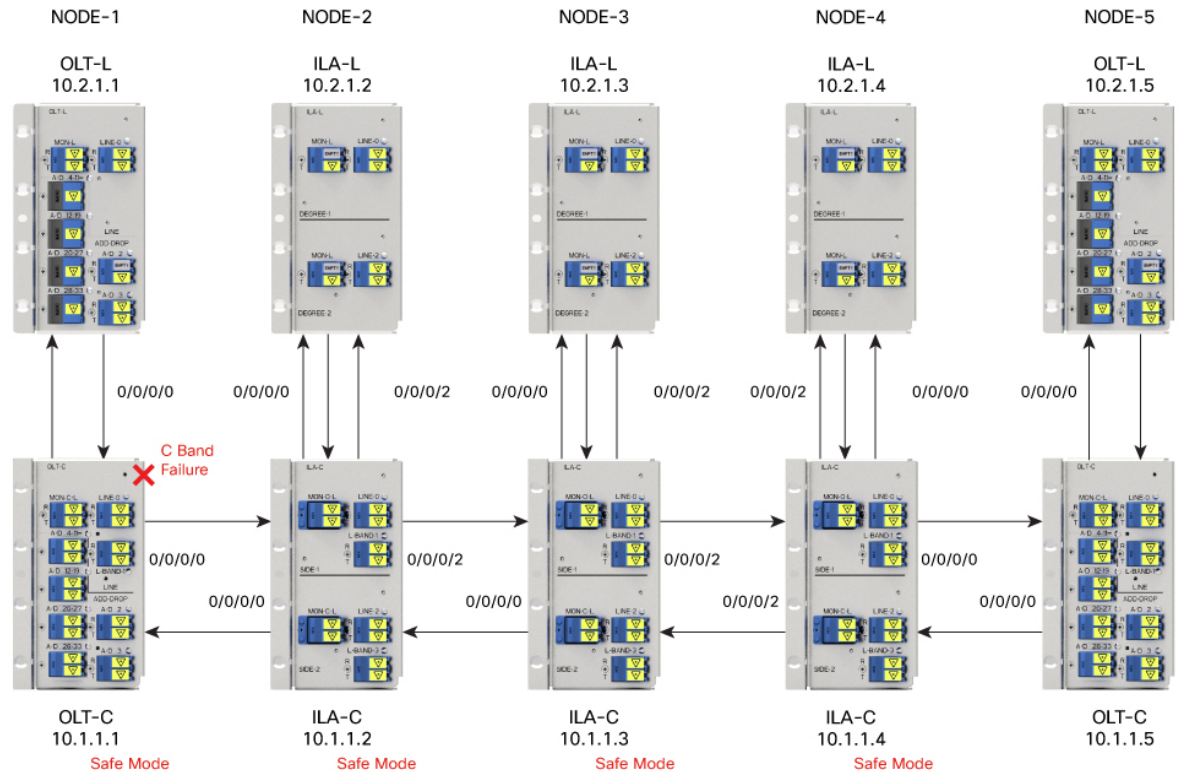
Figure 2: Example of C-band Failure on a C+L Band Network

In this section, we will troubleshoot C band failure due to amplifier shutdown or failure. To troubleshoot C-band failure on a C+L band network, start by running the following commands on the manager nodes in the same order:

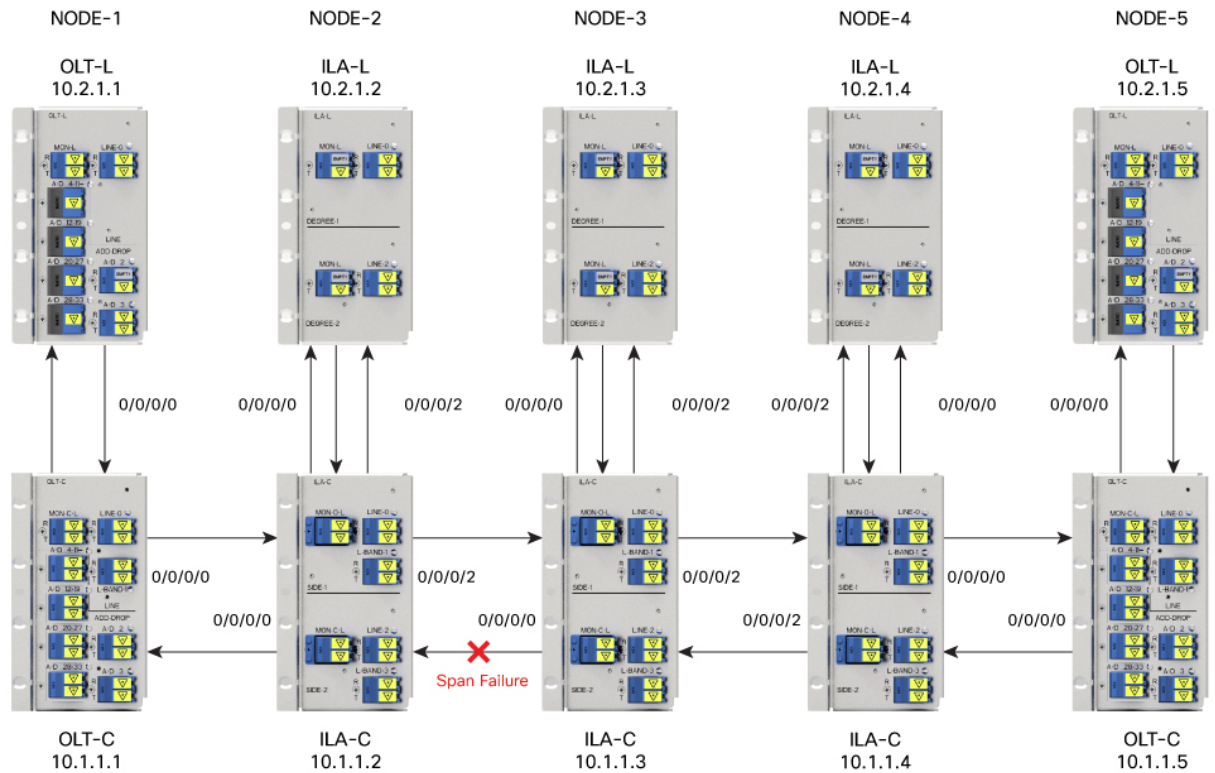
Figure 3: Example of Span Failure

To troubleshoot span failure on a C+L band network, start by running the following commands on the manager nodes in the same order:

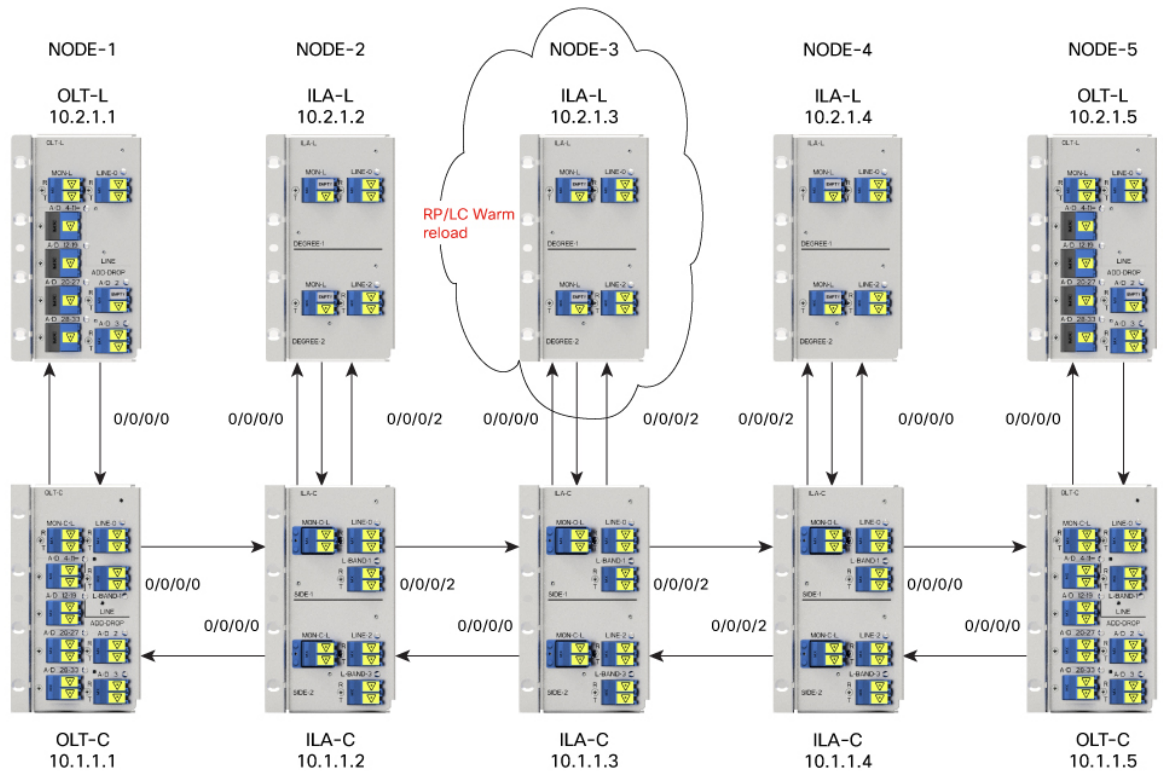
Figure 4: Example RP or LC Warm Reload Troubleshooting on C+L Band Network

On a C+L band network, RP or LC warm reload on a C or L band device might affect the partner band connectivity. In this case, traffic is not impacted. To troubleshoot a RP or LC warm reload on a C+L band network, following these steps:

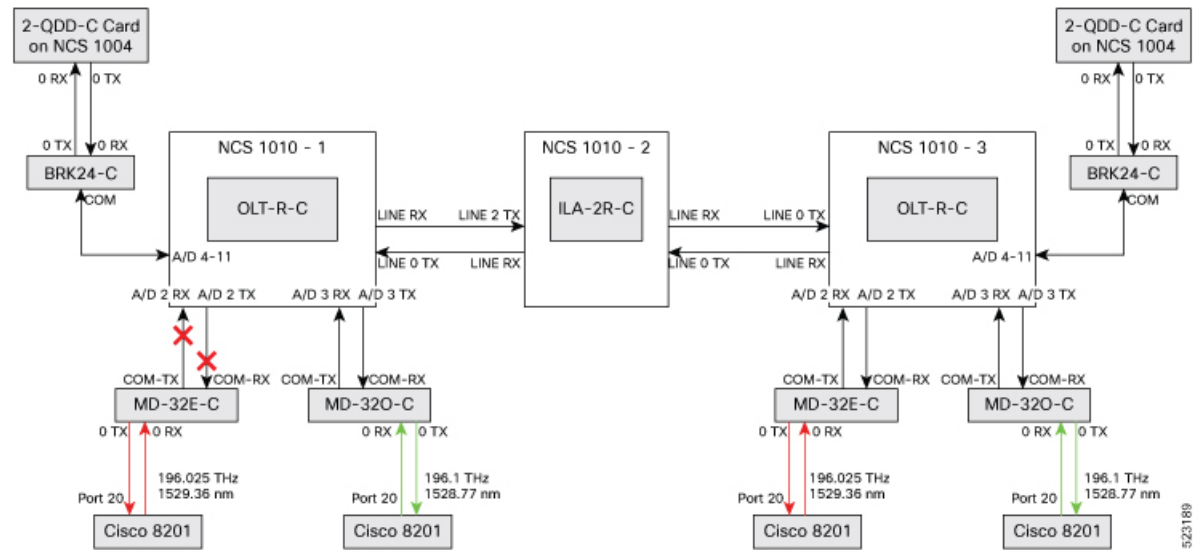
Figure 5: Fiber Cut at the AD Port OTS Controller and OMS Controller

The following figure displays client-side failure due to fiber cut:

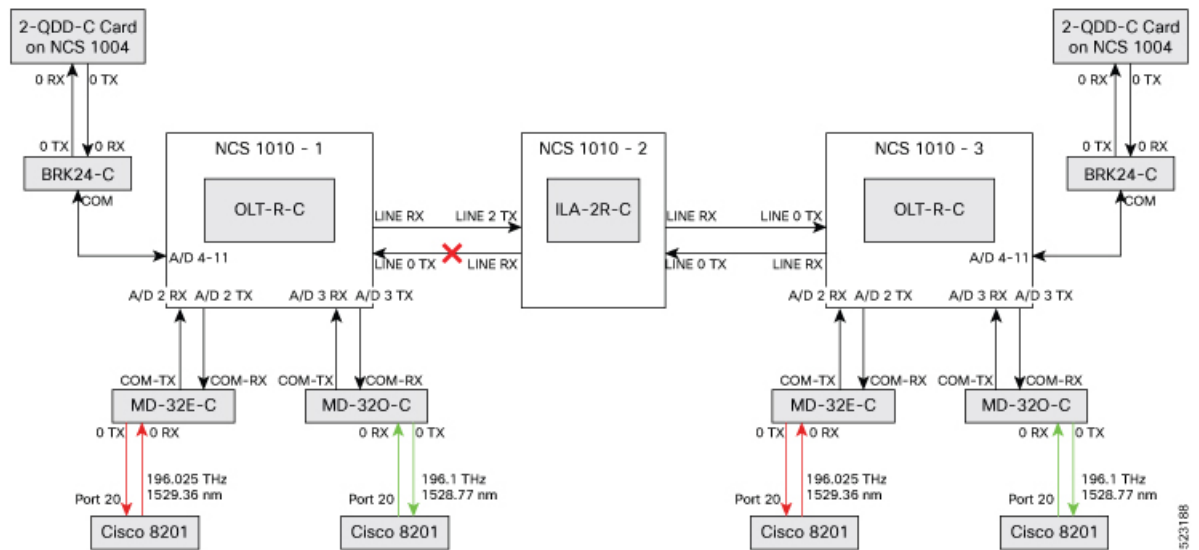
Figure 6: Fiber Cut at the Line OTS Controller

The following figure shows loss of fiber connection continuity at the Line port:

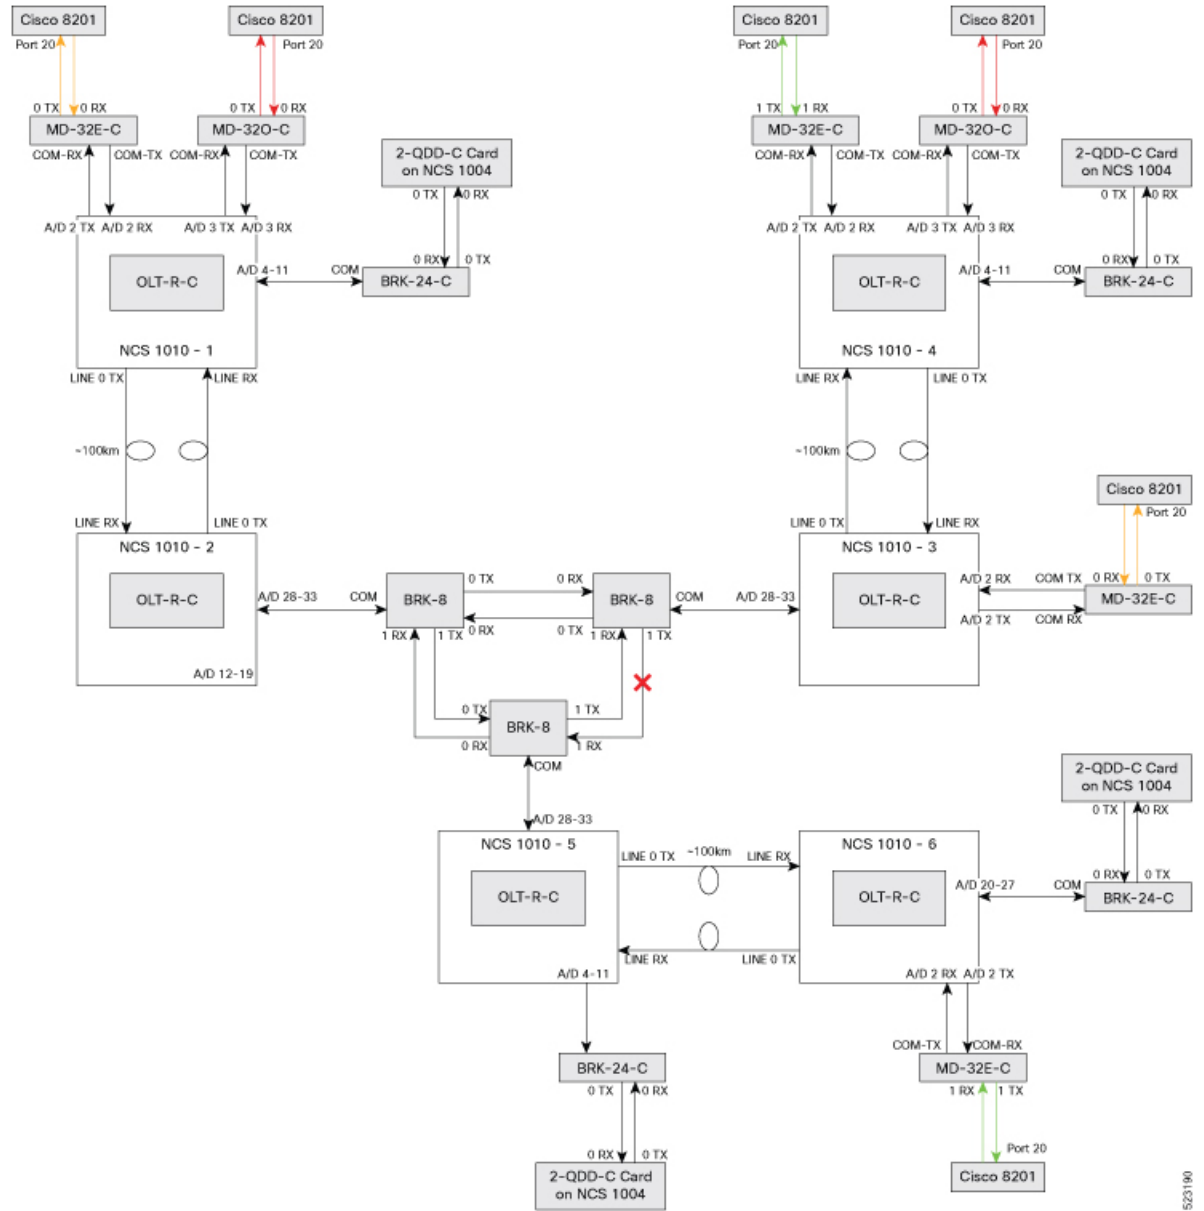
Figure 7: Fiber Cut Between Two Passive Devices

The following figure displays the fiber cut between two passive devices:

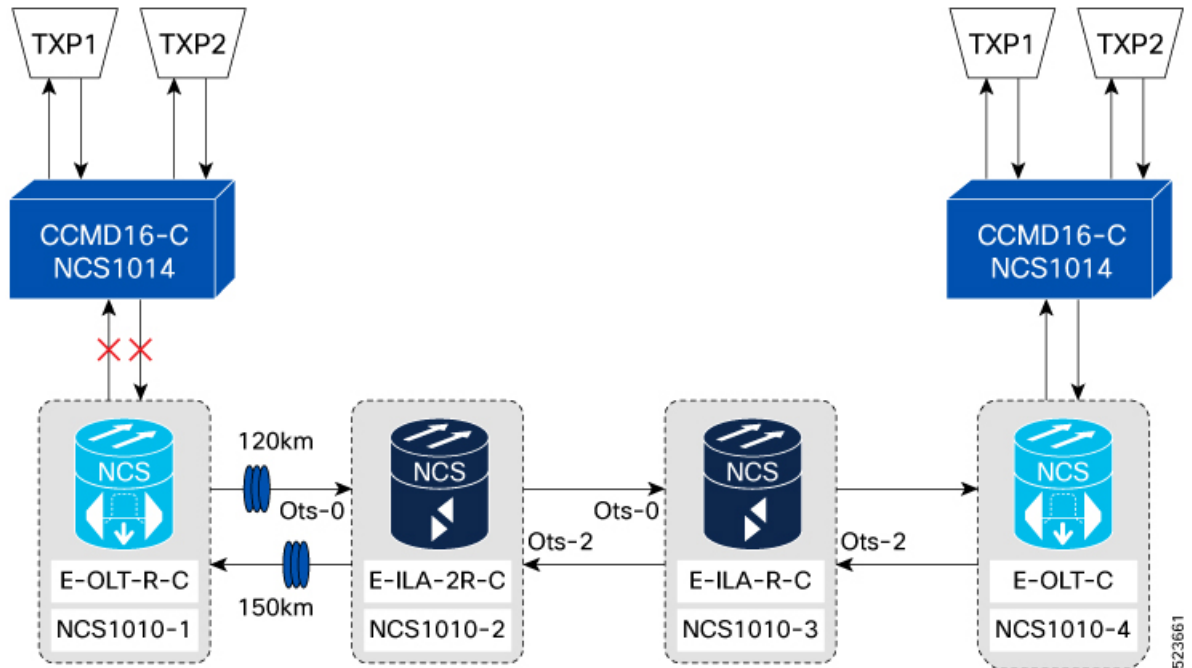
Figure 10: Fiber Cut Between CCMD and OLT

The following figure displays fiber cut between CCMD and OLT:

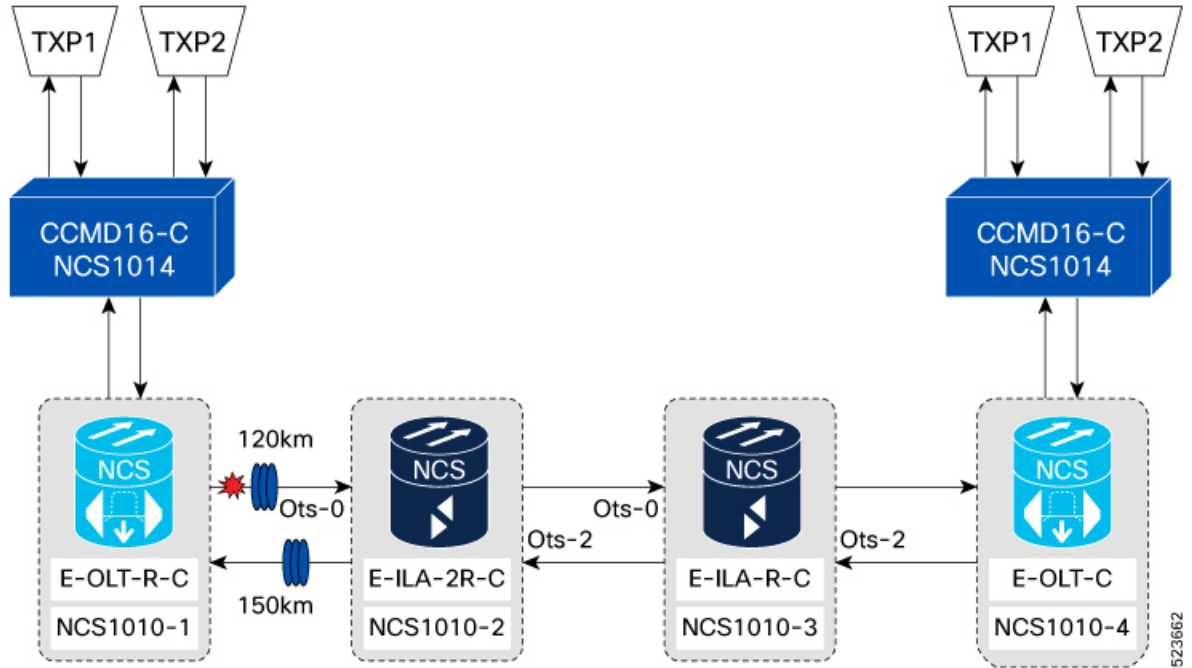
Figure 11: High Back Reflection Condition on the Line Tx port

The following figure displays high back reflection condition on the line Tx port:

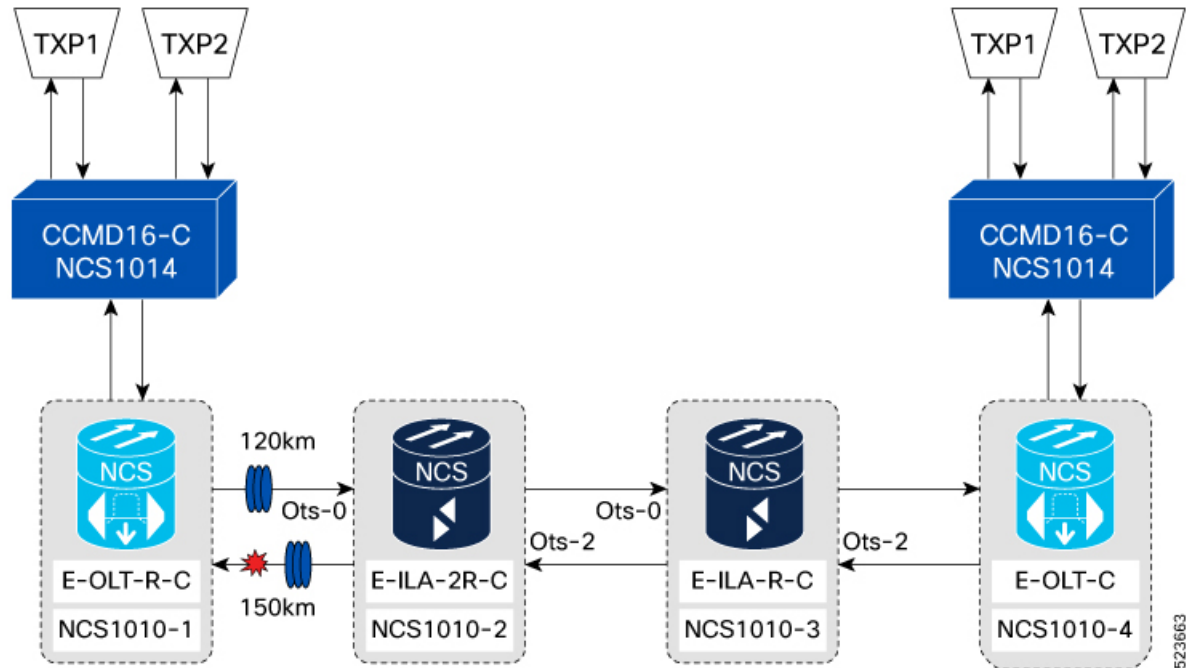
Figure 12: High Back Reflection Condition on the Line Rx RAMAN Port

The following figure displays high back reflection condition on the line Rx RAMAN port:

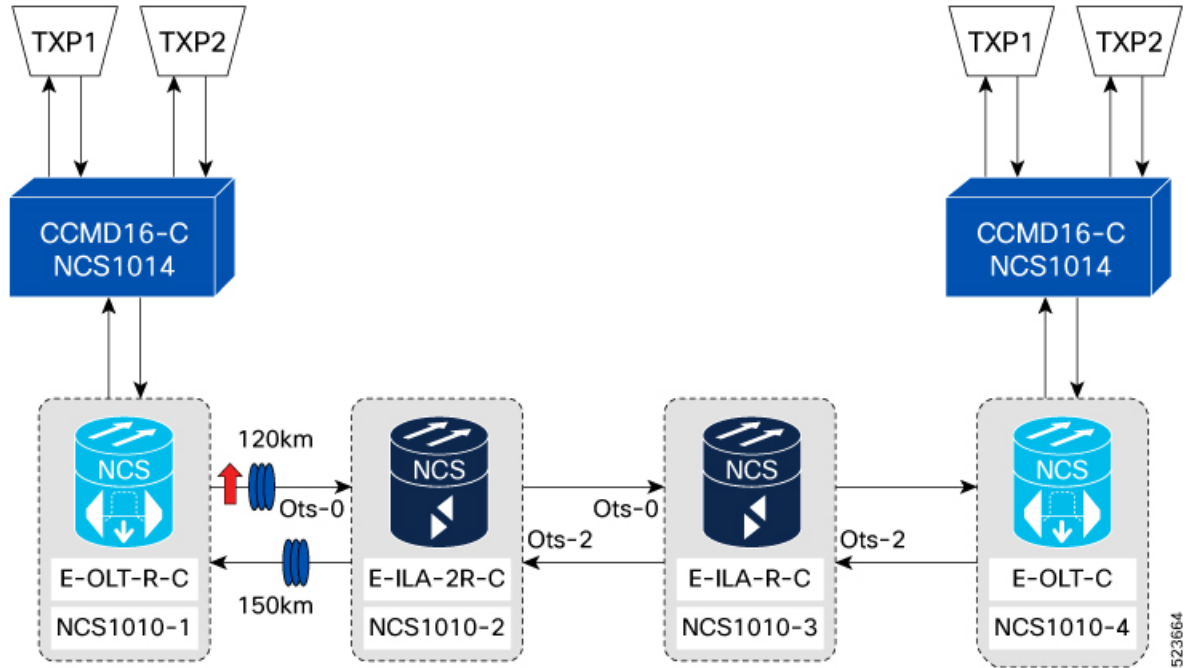
Figure 13: High span loss on Line Tx Port

The following figure displays high span loss on line Tx port:

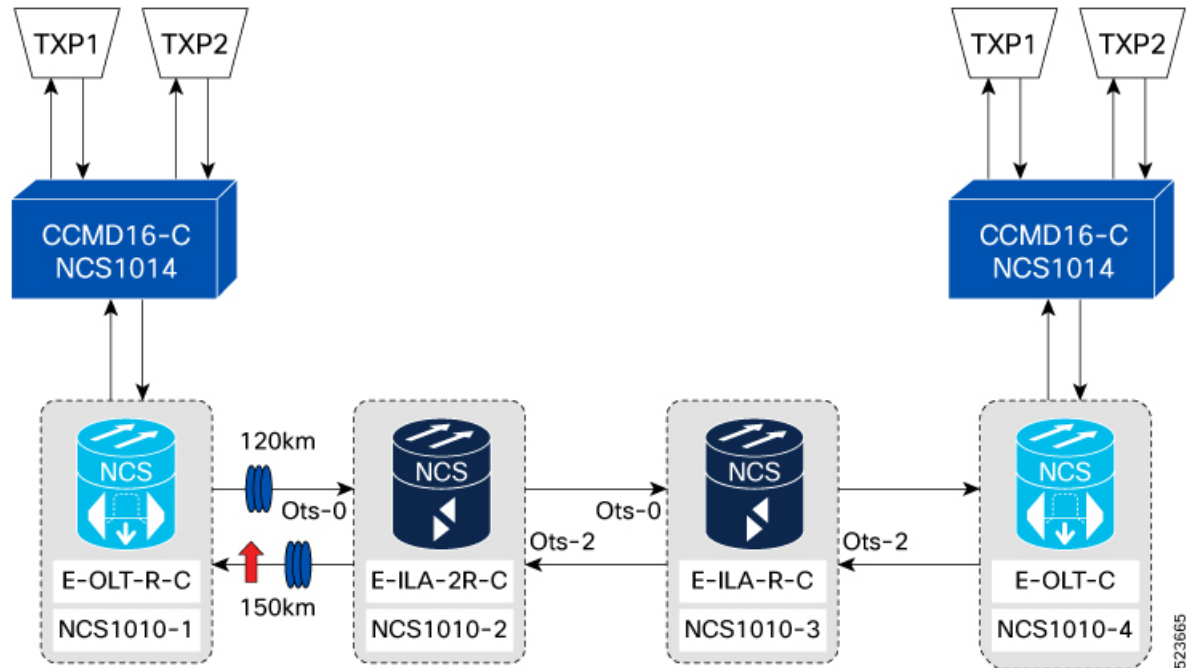
Figure 14: High span loss on Line Rx port

The following figure displays high span loss on the line Rx port:

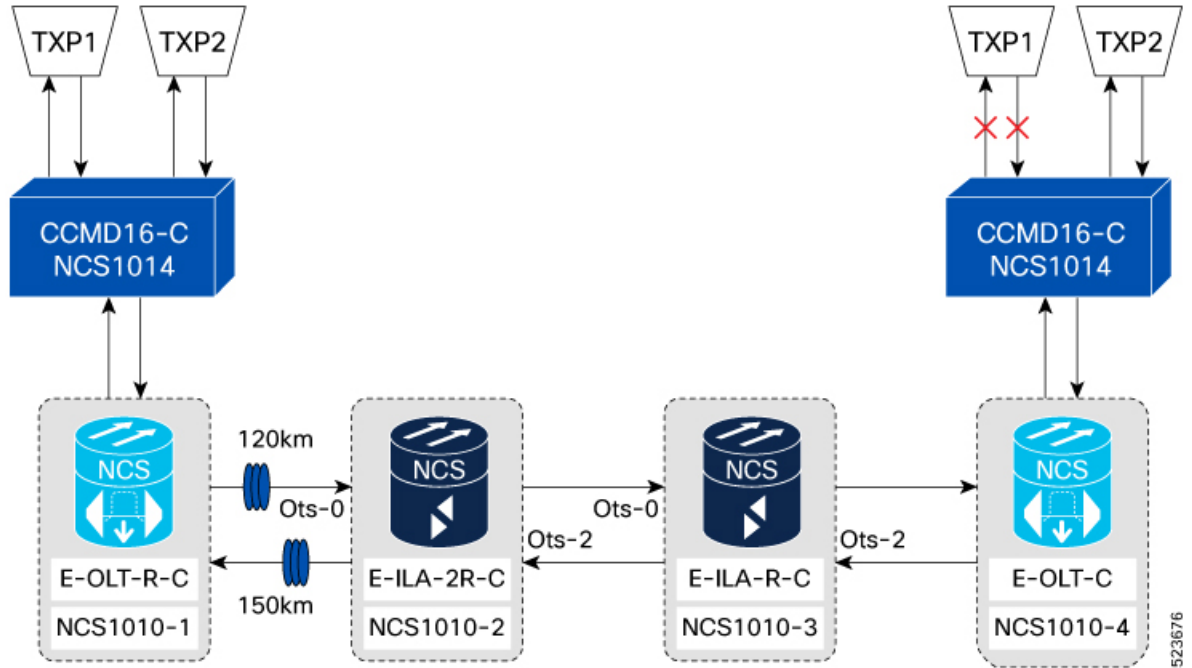
Figure 15: Single Channel Failure due to Bidirectional Fiber Cut on Line

The following figure displays single channel failure due to bidirectional fiber cut on line:

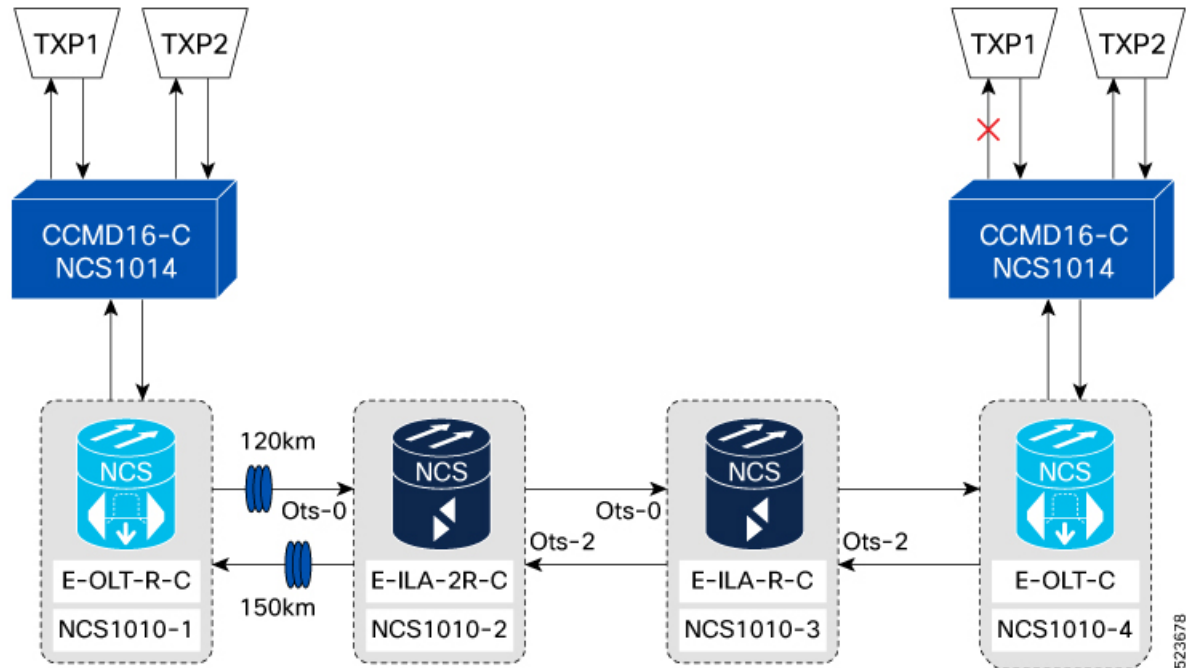
Figure 16: Single Channel Failure due to Unidirectional Fiber Cut at TXP-Tx

The following figure displays single channel failure due to unidirectional fiber cut at TXP-Tx:

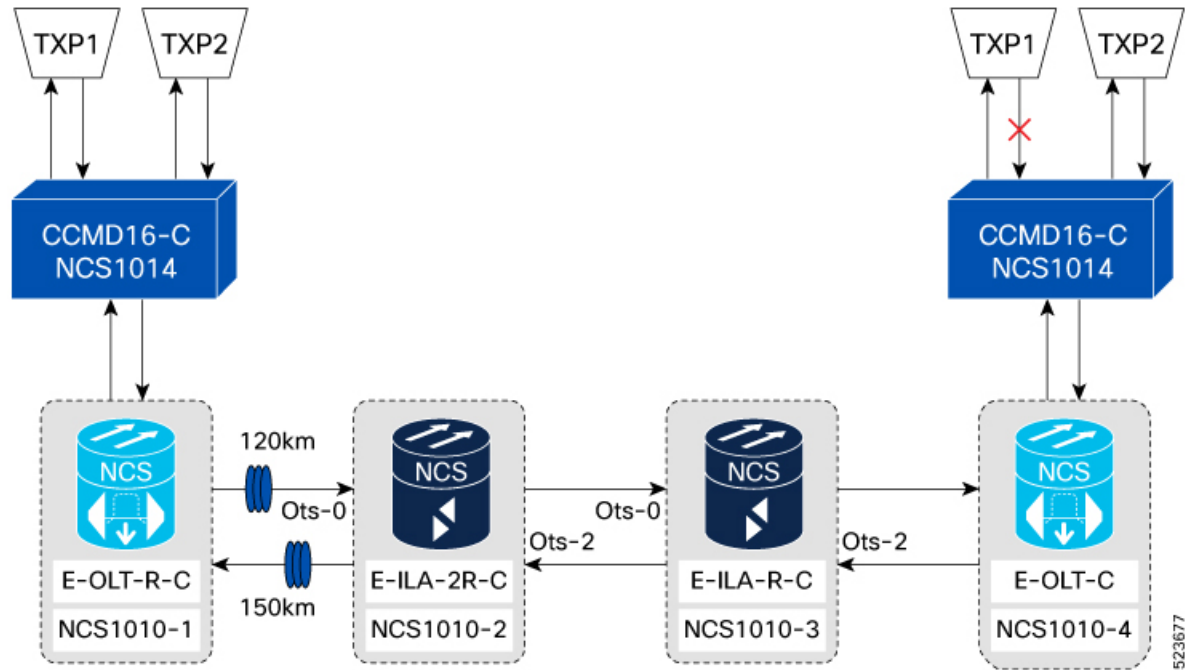
Figure 17: Single Channel Failure due to Unidirectional Fiber Cut at TXP-Tx

The following figure displays single channel failure due to unidirectional fiber cut at TXP-Rx:
